# SERVICE BULLETIN

BT13-018

## MURANO CONVERTIBLE TOP WILL NOT STOW COMPLETELY

**APPLIED VEHICLE:** 2011 - 2012 Murano convertible (Z51)

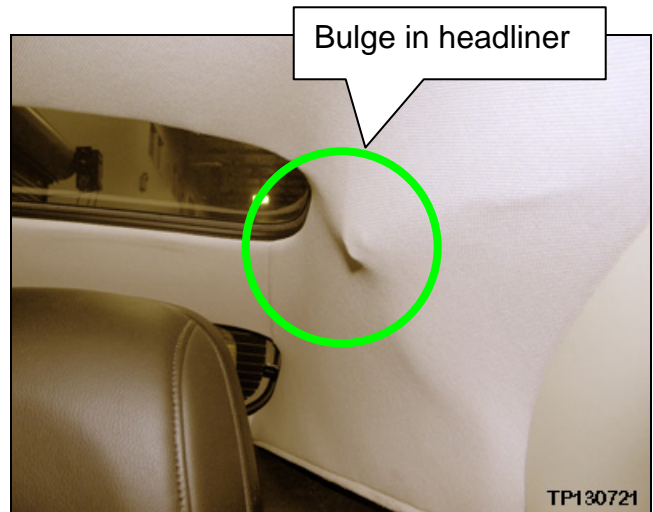
Figure 1

If the headliner has signs of an external bulge as shown in Figure 1, and/or will not completely open and stow:

- If either of the Skylight Window Links is separated from the Skylight Window Frame replace the Folding Roof Cover with the part listed in the PARTS INFORMATION.

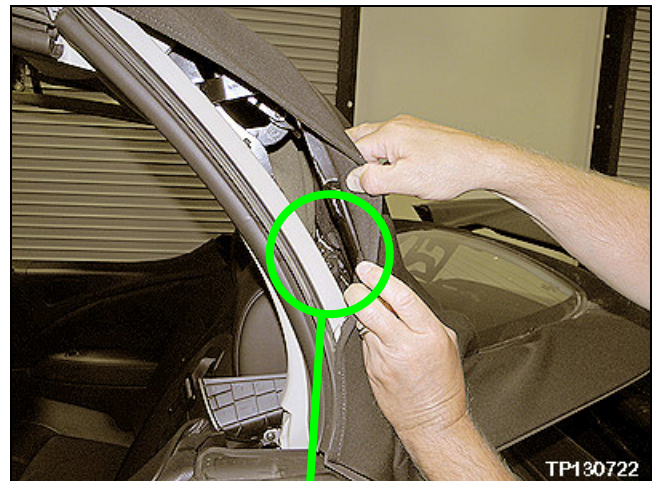
Figure 2

1. Open the convertible top enough so that the material can be pulled away from the frame assembly (Figure 2).
2. Inspect both left and right Skylight Window Links for separation from the Skylight Window Frame (Figure 2 and Figure 3).
3. If either link has separated on the left or right sides, replace the Folding Roof Cover.
  - Figure 4 on page 3 shows an additional view of a separated Skylight Window Link with headliner removed from the Skylight Window Frame and is for reference only.

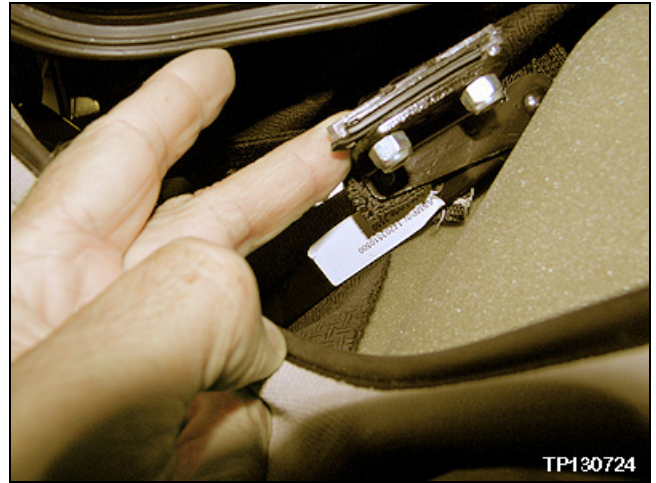
Figure 4 shows the separation of the Skylight Window Link from the Skylight Window Frame.
