## Service Bulletin 497

May 2013

**Affected Models** ..... Bonneville, Bonneville T100 and Bonneville T100 Black

**Subject** ..... Ignition Switch

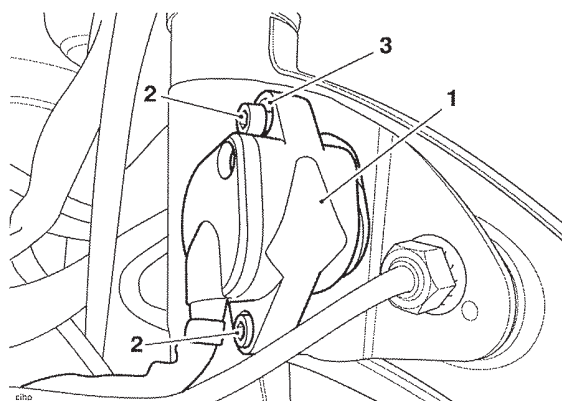
We have identified that there is a possibility that the spring washers for the ignition switch screws may be missing on the above models. Dealers are requested to remove and refit the ignition switch screws with spring washers.

1. Ignition switch
2. Fixings
3. Spring washer

1. Fit the spring washers to the fixings. Refit the ignition switch to the headlight mounting bracket and tighten the fixings to **5 Nm**.
