## Service Bulletin 504

**Affected Models** .....Tiger Sport ABS

**Subject** .....Additional Clip - Rear ABS Sensor Wire

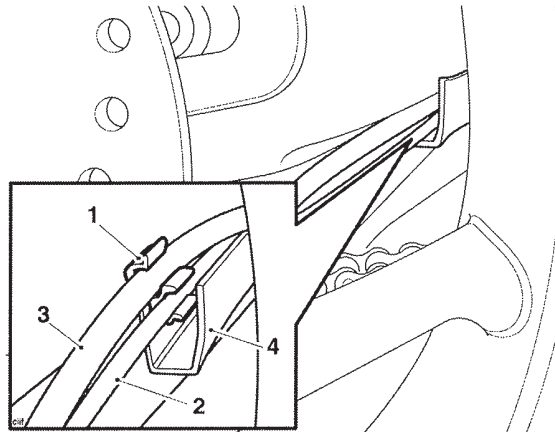
1. Clip
2. Rear ABS sensor wire
3. Rear brake hose
4. Rear brake hose cover

1. Check the exposed section of the rear ABS sensor wire for damage.
  - If the wire is not damaged, proceed to step 2.
  - If the wire is damaged, replace the rear ABS sensor and set the ABS sensor air gap as described in the Service Manual, then proceed to step 2.
2. Fit the retaining clip to the rear ABS sensor wire and rear brake hose as shown below, ensuring that the clip is positioned within 5 mm of the end of the rear brake hose cover.
