### Contents

### Item 1.

**Description:** Sliding Selector Shaft and Detent Assembly

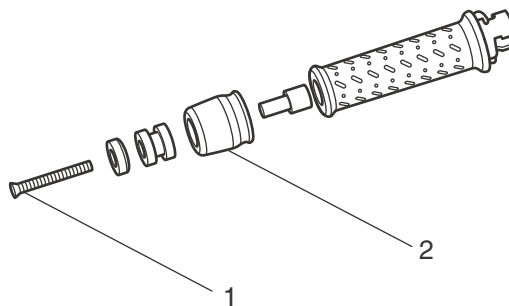
**1. Fixing**

**2. Handlebar end weight**

The torque figure for the handlebar end weight fixing has changed to **5 Nm** on the above models.

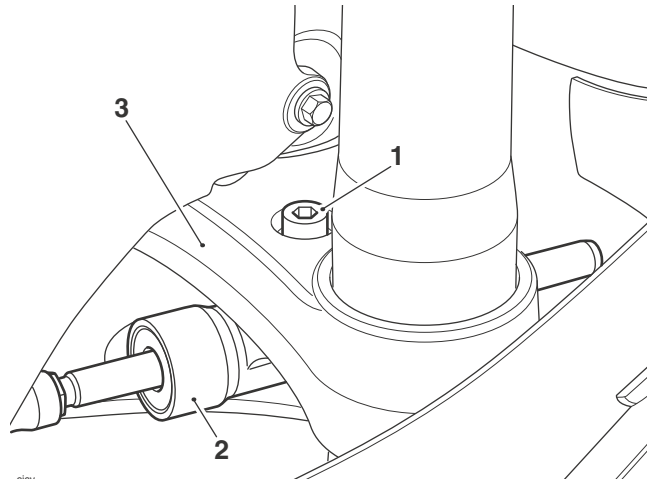
1. Fixing
2. Steering damper
3. Lower yoke

The torque figure for the steering damper fixing to the lower yoke has changed to **20 Nm** on the above models.

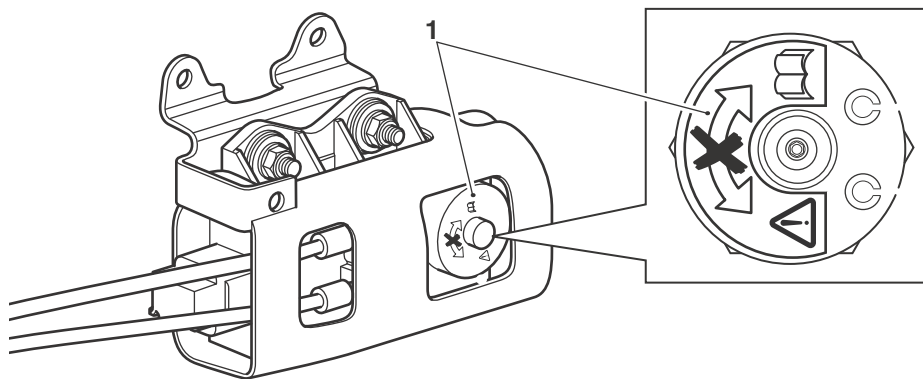
The Daytona 675 and 675 R from VIN 564948 are now fitted with a new design of exhaust butterfly valve actuator. The new internal mechanism means it is no longer possible to rotate the pulley wheel without causing damage to the internal drive gear.

If for any reason the pulley wheel is manually rotated internal damage will result and a new actuator will be required.

**1. Warning label**

Therefore when checking the operation of the exhaust butterfly valve actuator, always use the Function Test feature on the Triumph Diagnostic Tool.

Do not rotate the pulley on the exhaust butterfly valve actuator. Rotating the pulley will damage the internal components of the actuator.

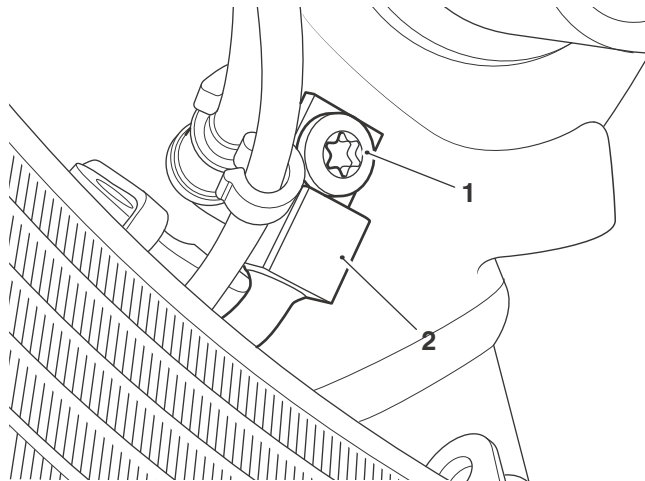
- 1. Fixing
- 2. Bracket

The torque figure for the ABS headstock brake pipe union fixing has changed to **15 Nm** on the above models.

- **Models already in service need not be re-tightened unless the fixings have been loosened or removed.**
- **If removed for any reason the fixing must be replaced.**

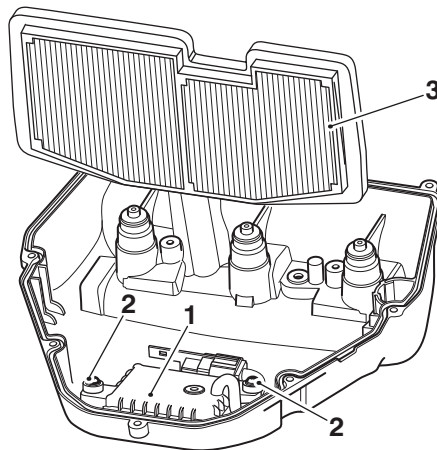
1. Immobiliser
2. Fixing
3. Air filter element

The torque figure for the engine immobiliser fixings has changed to **1.5 Nm** on the above models.

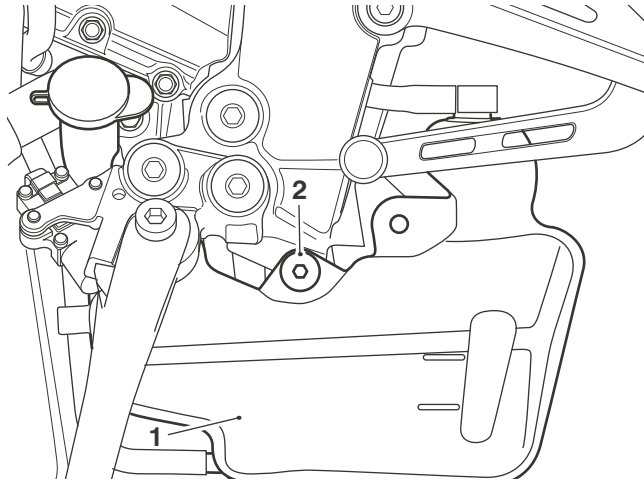
1. Coolant expansion tank (cover removed)

2. Fixing

The torque figure for the coolant expansion tank fixing has changed to **7 Nm** on the above models.

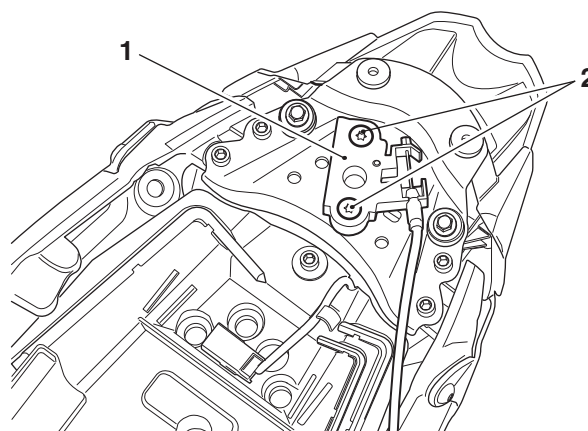
1. Seat lock

2. Fixings

The torque figure for the seat lock fixings has changed to **5 Nm** on the above models.

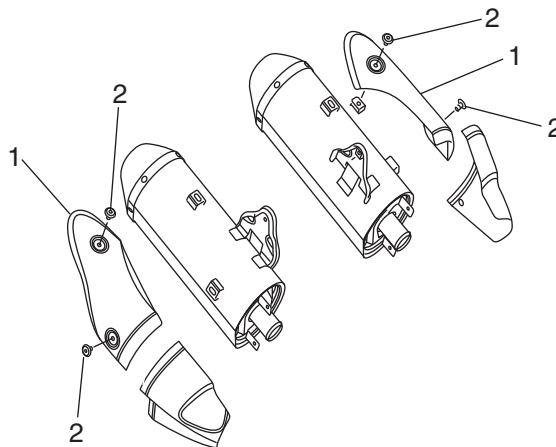
1. Heat shield

2. Fixings

The torque figure for the silencer heat shield fixings has changed to **8 Nm** on the above models.

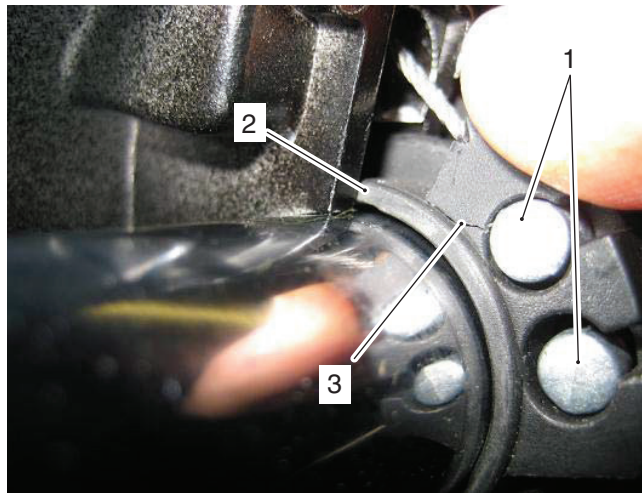
It has come to our attention that a small number of twist grip bodies are cracking in the area where the throttle cables are attached to the twist grip. See picture below.

Following our investigations, we note that this damage will only occur when throttle cable free play has been incorrectly adjusted and the free play has been reduced or removed completely.

1. Throttle cables
2. Twist grip body
3. Cracked area

To avoid incorrect adjustment, incorrect routing, or continued use of a sticking or damaged throttle, always have the throttle checked and adjusted by your authorised Triumph dealer.

The owner's handbook and service manual both state that there must be 2-3 mm of free play in the throttle cables which is measured at the throttle grip.

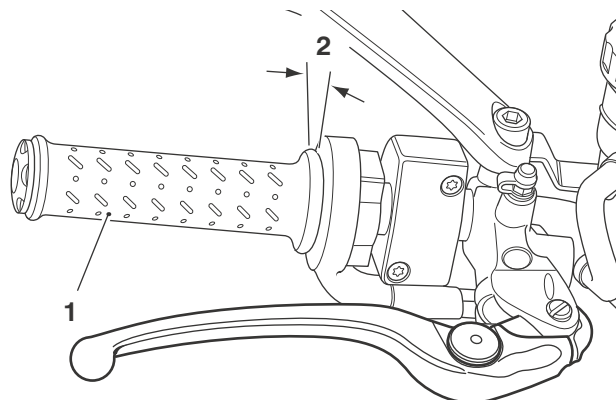
1. Throttle grip
2. Correct setting, 2-3 mm

Refer to the service manual when fitting or adjusting the throttle cables.

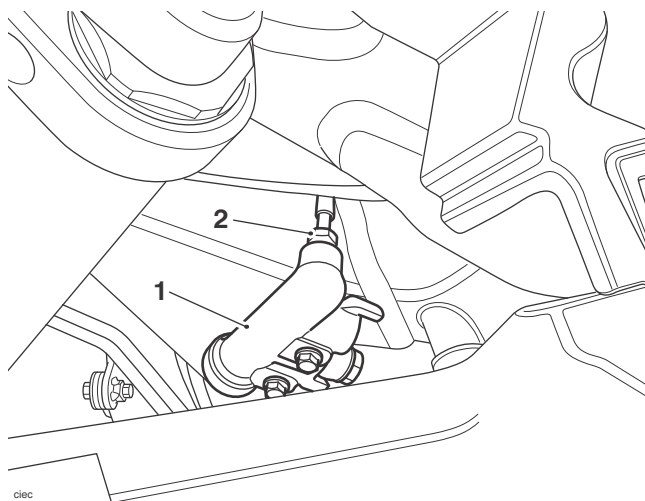
### Delay Valve

- 1. Delay valve
- 2. Brake line union

The torque figure for the brake line unions listed below have changed to **15 Nm** on the above models.

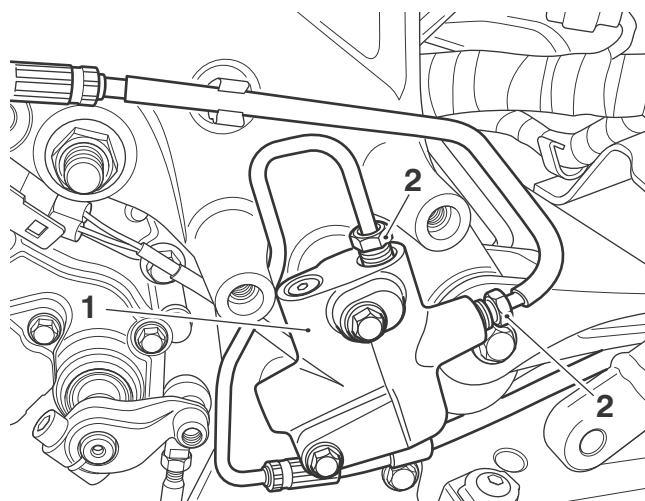
### Proportioning Valve

- 1. Proportioning valve
- 2. Rear brake line unions

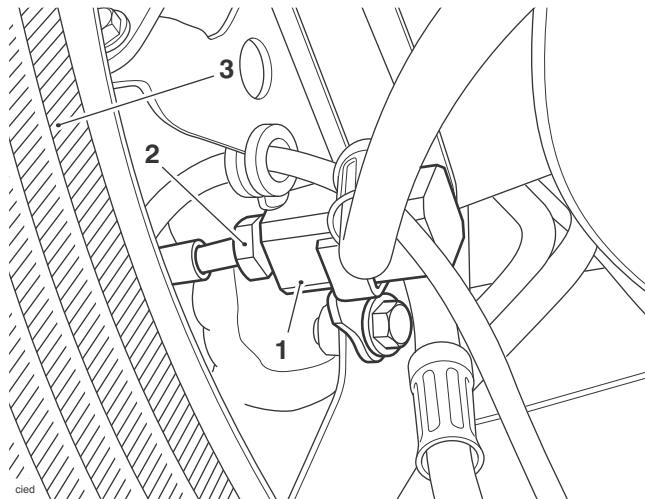
**Front Brake Hose Manifold**

- 1. Front brake hose manifold
- 2. Brake line union
- 3. Radiator
