# Technical News

Issue 142

March 2013

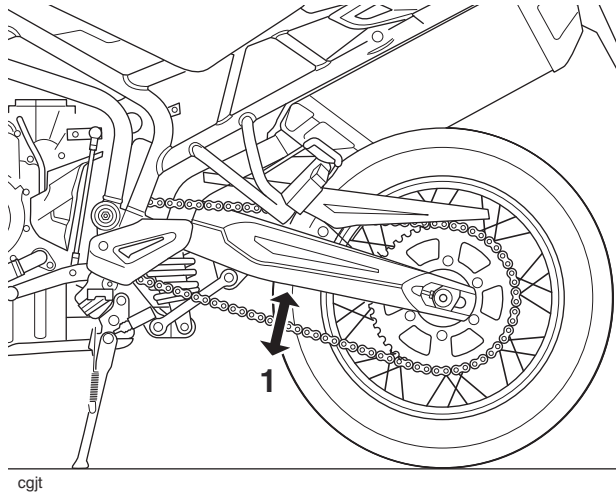
The drive chain vertical movement setting has changed to 20 - 30 mm for the above model. This change affects all bikes from the start of production.

**1. Maximum movement position**

For the procedure to check and adjust the drive chain vertical movement setting refer to the service manual or owner handbook.

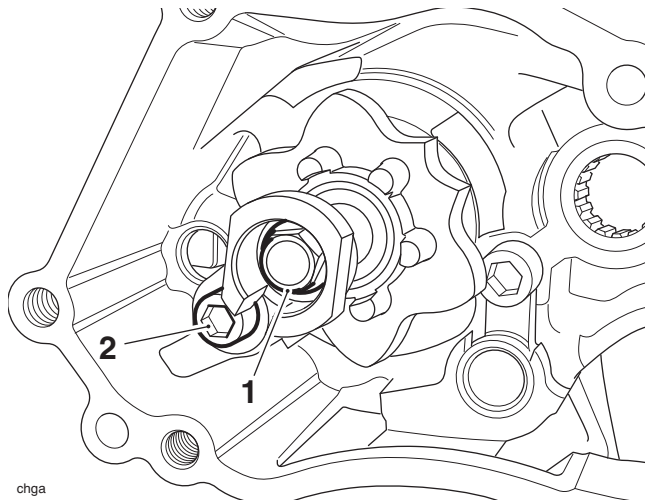
The torque figures for the detent wheel and selector drum bearing keeper plate fixings have changed on the above models. The new torque figures are as follows:

- Detent wheel fixing - **11 Nm**
- Selector drum bearing keeper plate fixing - **9 Nm**

**1. Detent wheel fixing**

**2. Selector drum bearing keeper plate fixing**

- **Models already in service need not be re-tightened unless the fixings have been loosened or removed.**
- **The detent wheel and selector drum bearing keeper plate fixings must be replaced if they have been loosened or removed.**

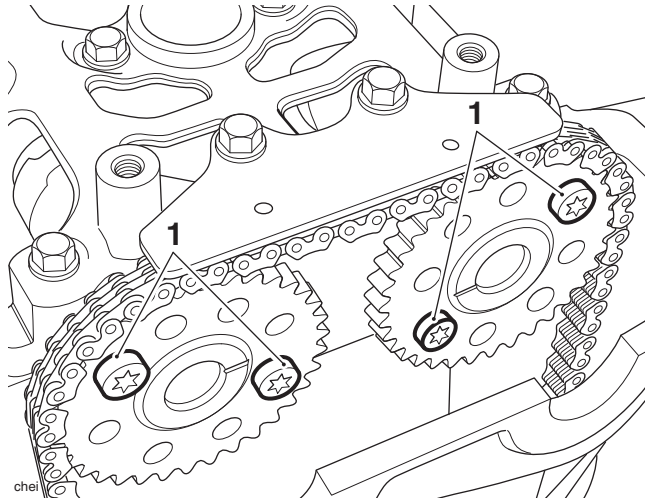
#### 1. Fixings

If the fixings for the camshaft sprockets have been loosened or removed they must be discarded. New fixings must be installed with a drop of ThreeBond 1375B locking compound (or equivalent) to the threads.

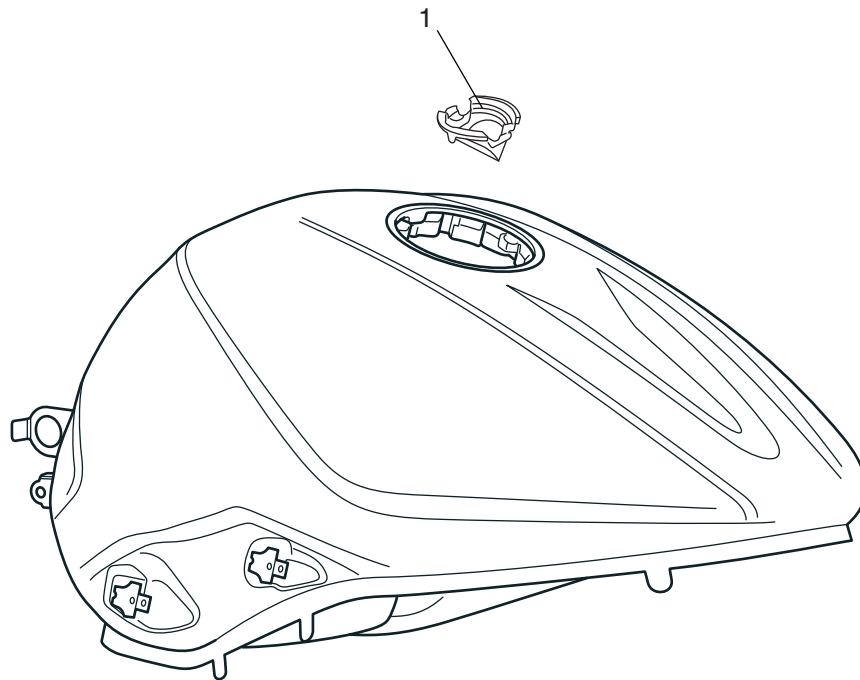
The fuel filler baffle is no longer fitted to the fuel tank on the above models from VIN 579045.

**1. Fuel filler baffle**

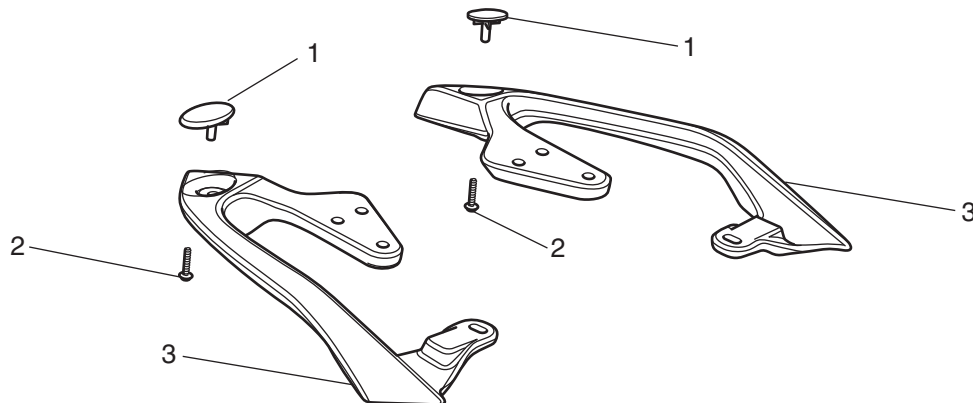
The torque figure for the fixings securing the finisher cap to the grab handles has changed to **1 Nm** on the above models.

1. Finishers cap

2. Fixings

3. Grab handles

- **Models already in service need not be re-tightened unless the fixings have been loosened or removed.**

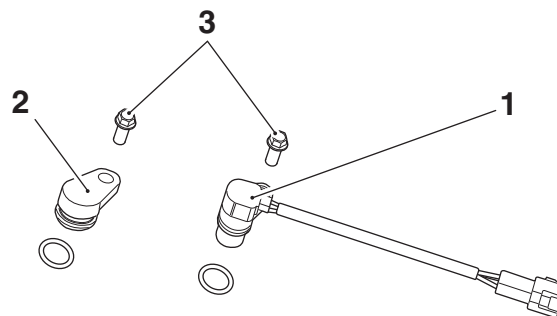
A new road speed sensor/blanking plug fixing (part number T3205064) has been introduced on the above models from VIN 574316 and is retrofittable. The torque figure has also changed to **4 Nm** to coincide with the introduction of the new fixing.

1. Road speed sensor (non ABS models only)

2. Blanking plug (ABS models only)

3. Fixing

- **Models already in service need not be re-tightened unless the fixings have been loosened or removed.**
- **The road speed sensor/blanking plug fixing must be replaced if it has been loosened or removed.**

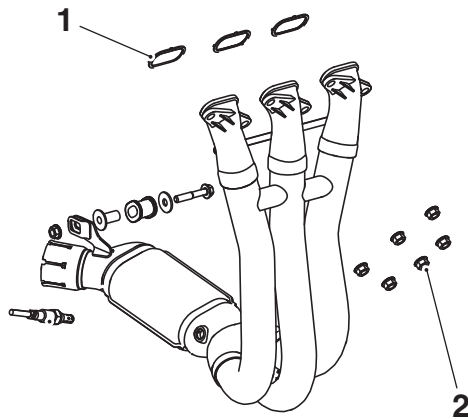
A new exhaust header seal has been introduced on the above models from VIN 584513. The torque figure for the exhaust header pipe fixings has also changed to **23 Nm** to coincide with the introduction of the new header seal.

| <b>Old Condition Seal:</b><br>Part Number 2201140<br>Header Fixing Tightened to <b>19 Nm</b> | | <b>New Condition Seal:</b><br>Part Number 2201157<br>Header Fixing Tightened to <b>23 Nm</b> | |
| <b>Identification:</b><br>Copper cladding on front, back and internal edge only.<br>No copper cladding on external edge. | | <b>Identification:</b><br>Completely copper clad. | |

- 1. Seal
- 2. Fixing

- **Models already in service need not be re-tightened unless the fixings have been loosened or removed.**
- **The new torque figure of 23 Nm must only be applied when replacing existing header seals with the new condition header seals.**
- **When replacing existing header seals with old condition header seals, the previous torque figure of 19 Nm must be applied.**

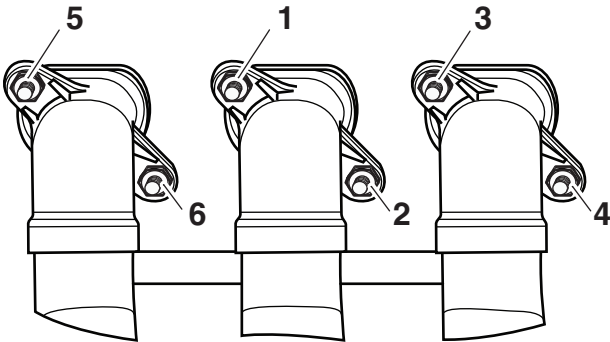
In addition there has also been a change to the exhaust header pipe fixing tightening sequence. When tightening the header pipe fixings follow the tightening sequence below.

- This tightening sequence can be applied when fitting either header seal type.

The new exhaust header seal is retrofittable to all earlier Tiger Explorer, Tiger Explorer XC, Trophy and Trophy SE models. When ordering parts always refer to the EPC.

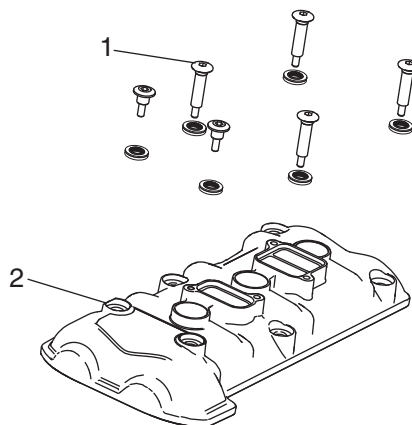
The torque figure for the camshaft cover fixings has changed to **12 Nm** on the above models.

1. Fixings

2. Camshaft cover

- Models already in service need not be re-tightened unless the fixings have been loosened or removed.
