Contents

- Item 1. Exhaust Butterfly Cables and Motor Assembly - Daytona 675 and Daytona 675R from VIN 564948
- Item 2. Headstock Washer and Bearing Adjustment - Tiger Sport

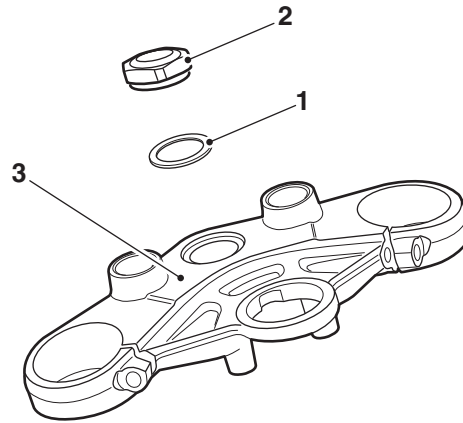
A washer (part number T3551551) has been introduced between the top yoke and the headstock top nut on the above model.

- 1. Washer
- 2. Headstock top nut
- 3. Top yoke

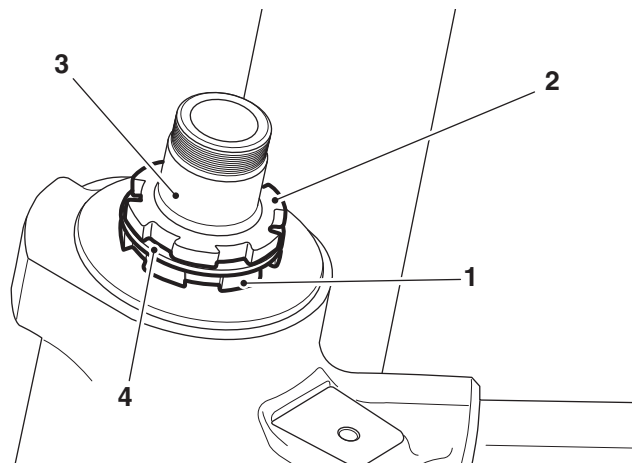
It is essential that the adjuster nut is not over-tightened. If the adjuster is over-tightened it will cause a pre-load on the headstock bearings. This will introduce tight steering, which could cause loss of control and an accident.

1. Adjuster nut
2. Lock nut
3. Stem threads
4. Tab washer

- Refit the adjuster nut and tighten to **40 Nm**.
 - Slacken the adjuster nut, then tighten to **8 Nm**.
 - Refit the tab washer and lock nut.
 - Hold the adjuster nut in position while tightening the lock nut to **40 Nm**.
2. Refit the top yoke to the forks.
 3. Fit the washer and the headstock top nut. Tighten the top nut to **90 Nm**.

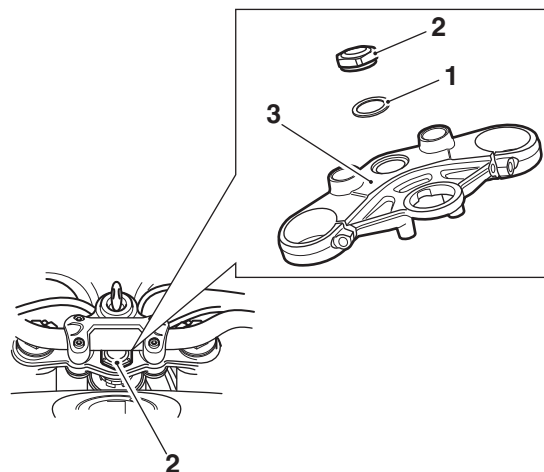
1. Washer
2. Headstock top nut
3. Top yoke

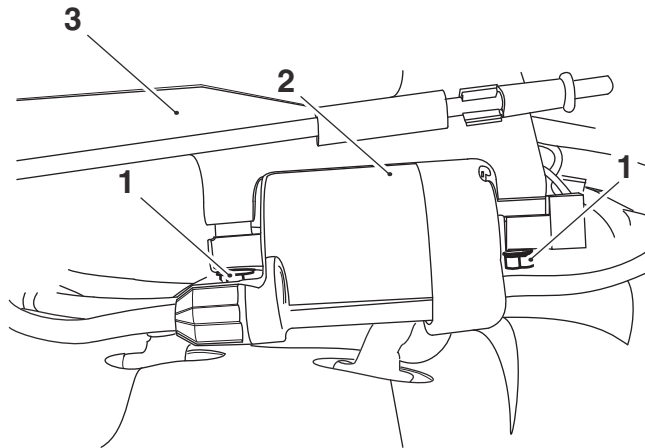
The torque figure for the fixings securing the ignition coils to the mounting bracket has changed to **9 Nm** on the above models.

- 1. Fixings
- 2. Ignition coil (front shown)
- 3. Bracket

Models already in service need not be re-tightened unless the bolts have been loosened or removed.

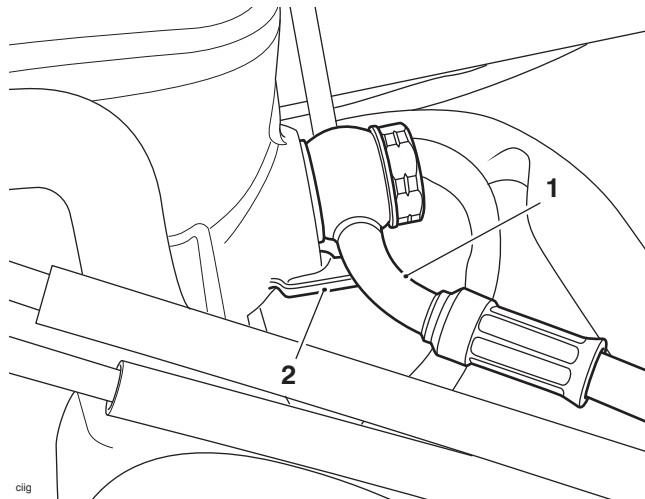
Dealers are reminded that the correct orientation of the front brake hose elbow on the above models is above the stop feature on the brake reservoir and not below as on other models.

1. Front brake hose
2. Brake reservoir stop feature

1. Position a new sealing washer on each side of the brake hose end fitting then secure the hose to the master cylinder with the banjo bolt.
2. Whilst counter-holding the brake hose elbow, tighten the banjo bolt to **25 Nm**.

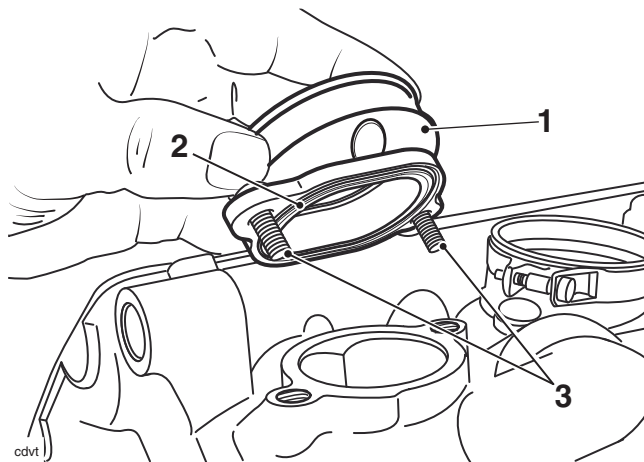
- The new transition pieces have a built-in rubber bead so the original O-rings are no longer required.

1. Transition piece

2. Rubber seal

3. Fixings

New encapsulated fixings have also been introduced. These must be replaced and tightened to **8 Nm** if they are loosened or removed.

If a transition piece has been removed for whatever reason, check the rubber bead for damage before refitting. If damaged fit a new transition piece.

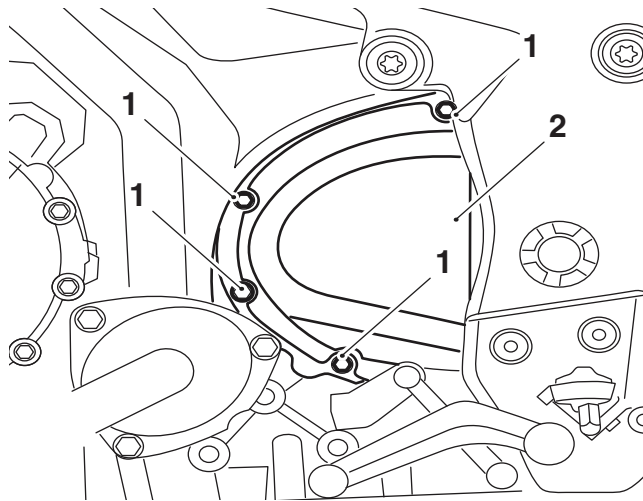
The sprocket cover fixing torque has been reduced on the above models. In addition the length of the fixing has been increased to 16 mm.

1. Sprocket cover fixing

2. Sprocket cover

The revised torque is **7 Nm**.

- **The M6 x 16 mm fixings need not be re-tightened unless they have been loosened or removed.**
- **The M6 x 12 mm fixings must be replaced with M6 x 16 mm fixings if they have been removed for any reason.**

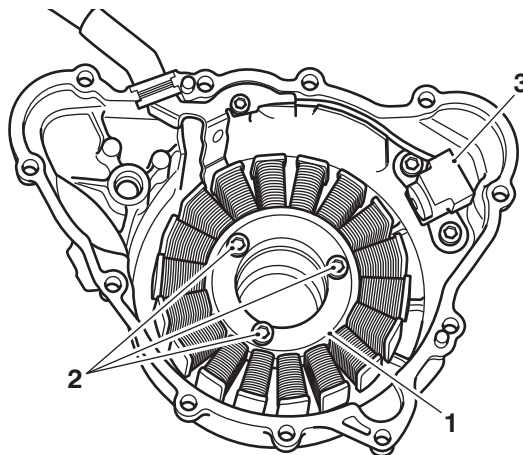
A new alternator assembly has been introduced to the above models from VIN 614941 and is not retrofittable. When ordering replacement parts, always refer to the EPC.

1. Stator
2. Stator fixings
3. Crankshaft position sensor

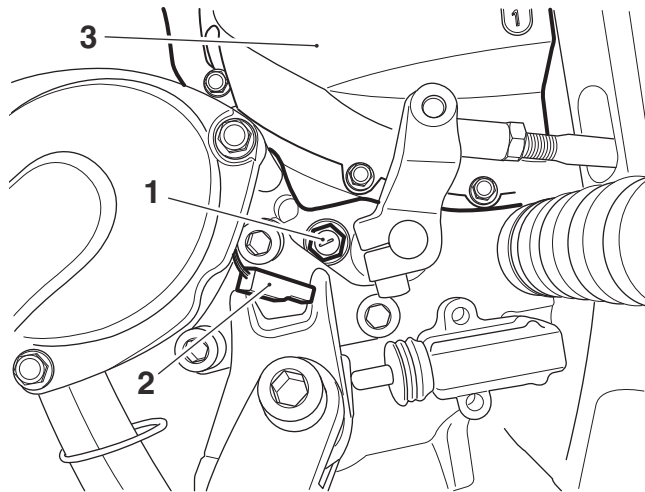
1. Neutral light switch - Speed Triple shown
2. Neutral light switch connection
3. Sprocket cover

4. Fit the neutral light switch and the 1.5 mm (silver) washer. Tighten to **10 Nm**.
5. Reconnect the neutral light switch to the main harness.
6. Reconnect the battery as described in the relevant Service Manual for each model. Do not refit the seat/battery cover at this stage.
7. Turn the ignition key to the ON position and ensure that the engine stop switch is in the run position.

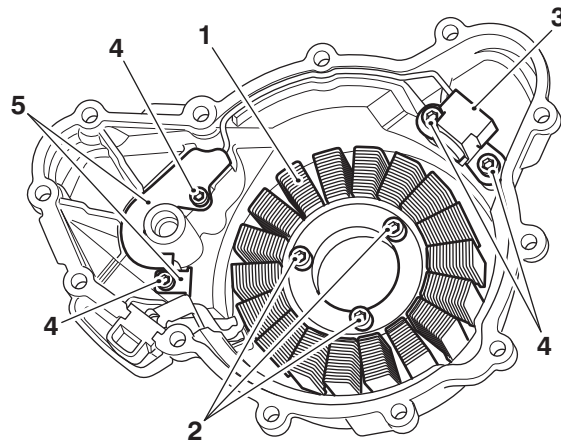
1. **Stator**
2. **Fixings**
3. **Crankshaft position sensor**
4. **Fixings**
5. **Cable brackets**

1. Fit the rotor, as described in the Service Manual.
2. Fit the stator to the alternator cover and tighten its new fixings to **12 Nm**.
3. Fit the crankshaft position sensor to the alternator cover and tighten its new fixings to **6 Nm**.
4. Route the harnesses as noted for removal, fit the cable brackets and tighten their new fixings to **6 Nm**.
5. Fit the alternator cover, as described in the Service Manual.

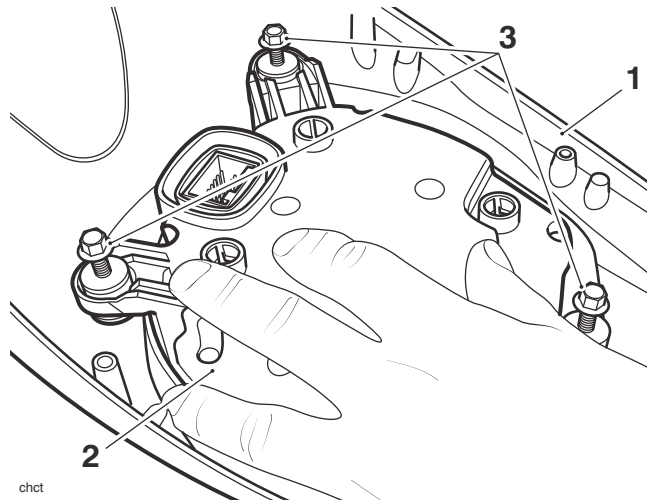
The torque figure for the instrument fixings has changed to **1.5 Nm** on the above models.

1. Instrument nacelle
2. Instrument assembly
3. Fixings

- **Models already in service need not be re-tightened unless the fixings have been loosened or removed.**
