US 51142327-03

Fork leg leaking

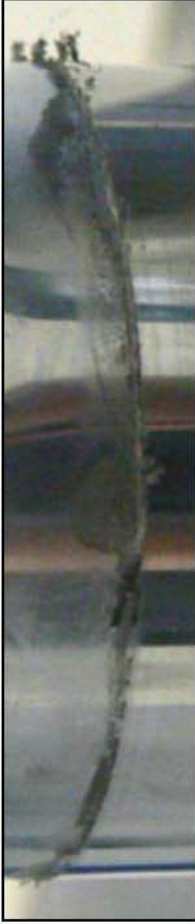
Fig. 1: fixed fork tube with ring of grease / dirt  
→ **Shaft seal ring not damaged**

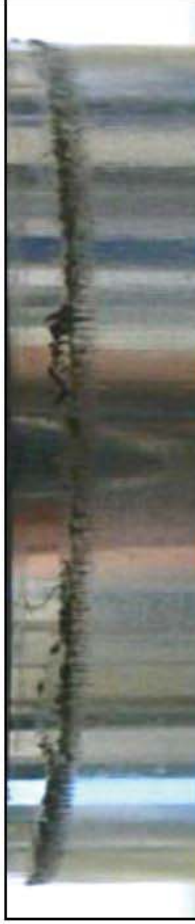
Fig. 2: fixed fork tube with ring of grease / dirt, slightly blurred  
→ **Shaft seal ring not damaged**

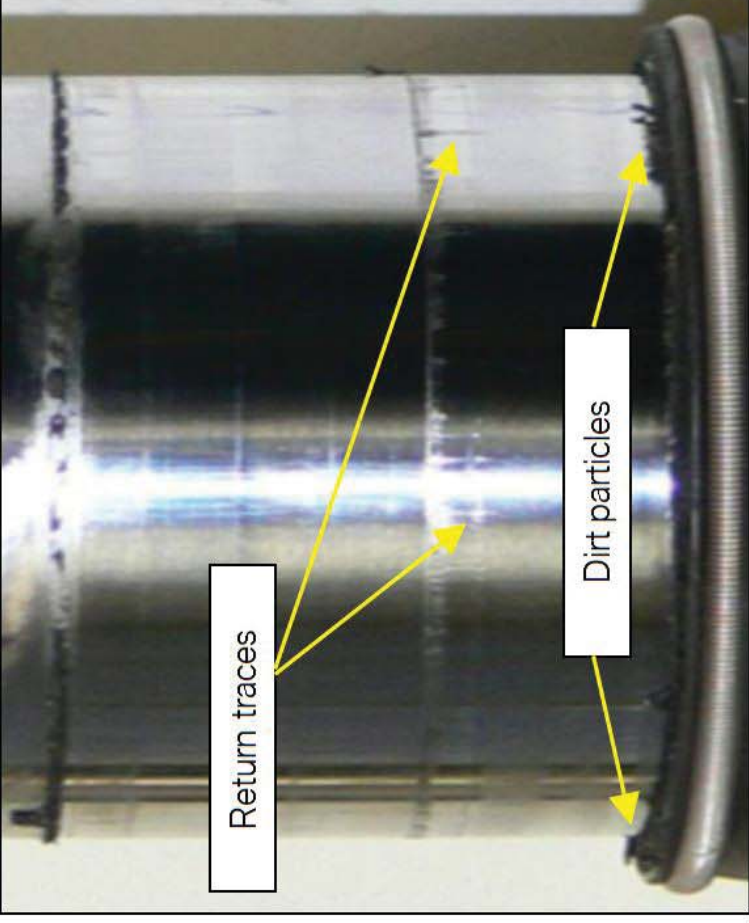
Fig. 3: fixed fork tube with initial traces of return on wiper ring

→ **Dirt contamination on the sealing lip can diminish the sealing function of the shaft seal ring and damage it.**

1. Assess the oil film on the fork stanchion and classify it according to the attached pictures.
2. If the oil film is similar to that shown in image 1 and 2, there are no leaks on the fork leg.
3. In image 3, a leak due to dirt can be clearly seen. In this case remove the dirt and then lift the dust cap using a suitable tool. Remove the oil that is located under the dust cap on the fork stanchion with a soft cloth and check the fork stanchion surface for damage. Then push the dust cap back into position. If oil appears (see image 4) after an extensive test ride on a clean shaft sealing ring, then it can be assumed that the shaft sealing ring is defective.
4. In image 4, crust formation can be clearly seen. There is either damage to the surface of the fork stanchion and/or a faulty shaft sealing ring.
