TECHNICAL BULLETIN
 UPS3113-1bNAS1
 04 JUN 2013

SECTION: 501-00

Right-Hand C-Pillar Outer Panel Split on Leading Edge

Freelander 2/LR2 (LF)
Model Year: 2013
VIN: DH356255-DH360221

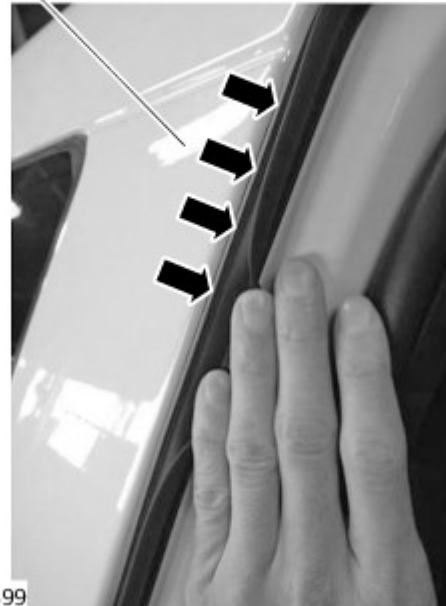
E157899

Situation: A potential concern has been identified on a number of 2013 model year LR2 vehicles where the leading edge of the outer panel on the right-hand C-pillar on the corner into the door shut area may be split.

**NOTE: The split that has been found is approximately 20cm in length and 2mm in width.**

At the right-hand C-pillar, hold back the seal to expose the panel and inspect for a split:

- If no split is found, record the inspection results on the repair order and release the vehicle.
- If a split is found, the vehicle **must** be withheld from sale or use pending further instructions.
