# Technical Service Bulletin

## 28 Fault stored in access start authorization control unit (DTC 02811)

28 13 22 2028419/2 November 15, 2013. Supersedes Technical Service Bulletin Group 96 number 12-28 dated January 27, 2012 for reasons listed below.

Model(s)	Year	VIN Range	Vehicle-Specific Equipment
A4	2009-2010	All	Not Applicable
A5	2008-2010	All	Not Applicable
Q5	2009-2010	All	Not Applicable

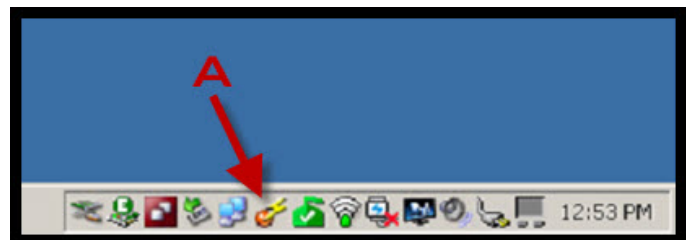
**Figure 1.** The Bluetooth wireless connection is disabled via the software switch (A) in the Windows taskbar.

SVM updates must only be performed using the USB wired connection to the VAS 5054 diagnostic head. The Bluetooth wireless connection must be disabled (Figure 1) to ensure that ODIS only uses the wired connection.
