74 Front center armrest is stuck, does not slide, or is inoperative

74 13 16 2035814/1 November 25, 2013.

Model(s)	Year	VIN Range	Vehicle-Specific Equipment
A4, A5	2012 - 2014	All	Not Applicable

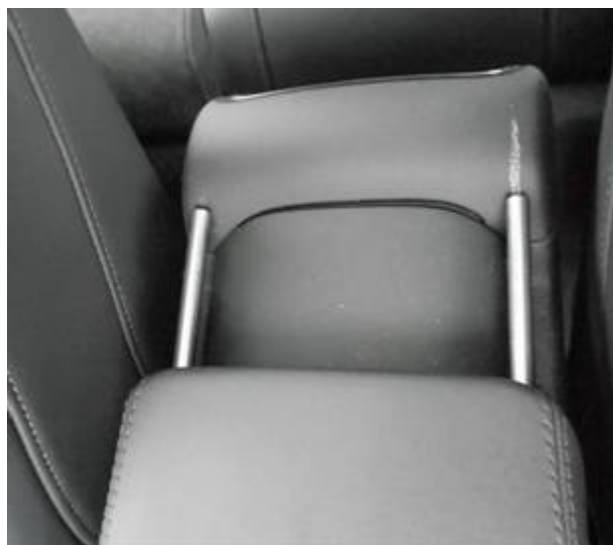
- Condition A: If the armrest slides past its limit and the rods are pulled out of the armrest (Figure 1), it is because the retention of the bracket is insufficient.
- Condition B: The armrest bracket is under tension because the guide plate has fallen loose from the bracket or the return spring has slipped from its original position

Figure 1. Detached rods that have pulled out of the armrest cover.

1. Replace armrest cover assembly according to the instructions in the Repair Manual.

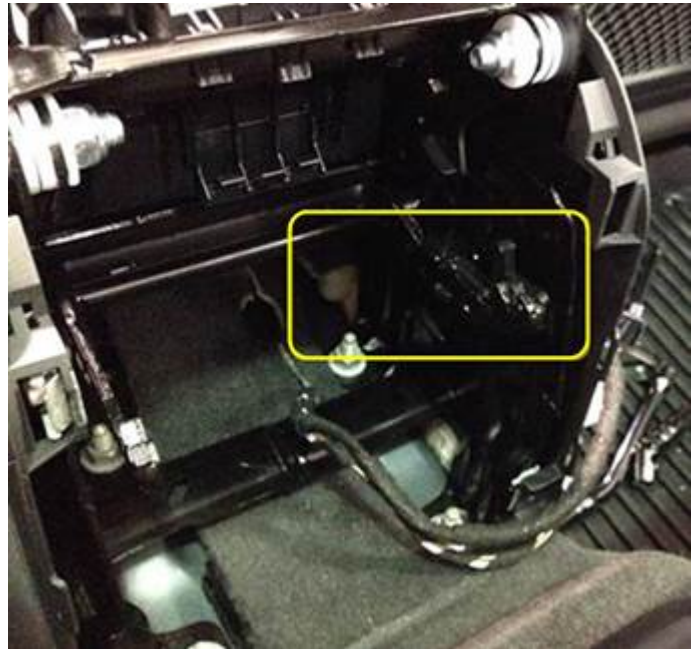
Figure 2. Rear cover of center console removed to expose guide plate (outlined).

1. Remove rear cover from center console to expose guide plate (Figure 2) according to the instructions in the Repair Manual.

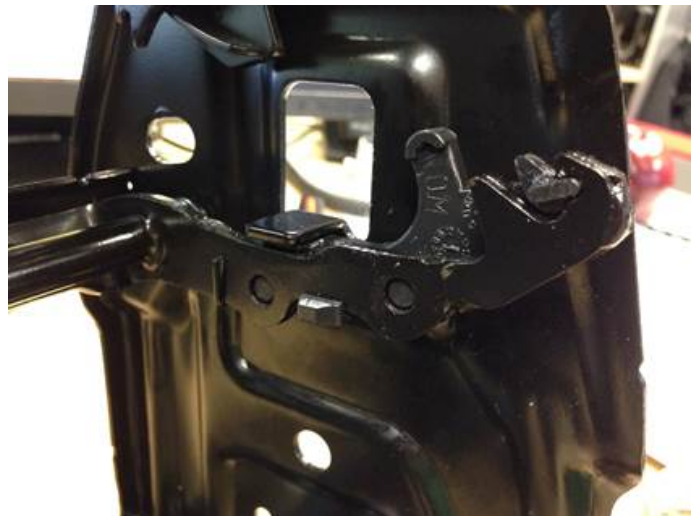
Figure 3. Bracket in correct position.

2. Inspect position of the guide plate:
 - If the position of the guide plate is correct (Figure 3), proceed to step 3.
 - If the position of the guide plate is incorrect (Figure 4), install the guide plate into the correct position, then check for proper armrest operation. If concern is still present, proceed to step 3.

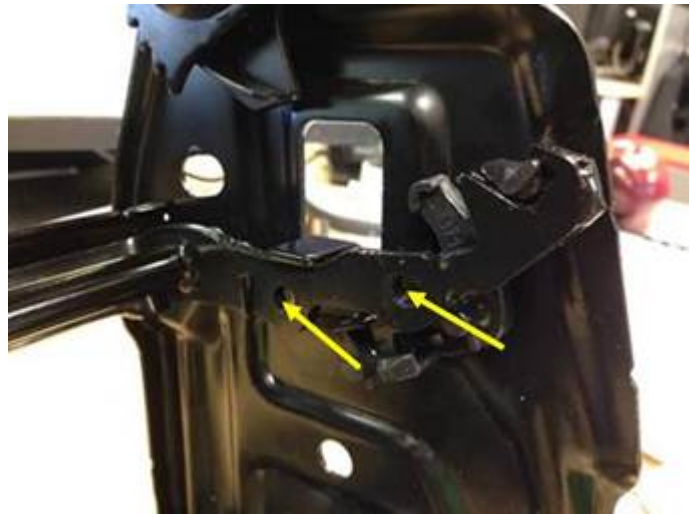
Figure 4. Bracket in incorrect position.

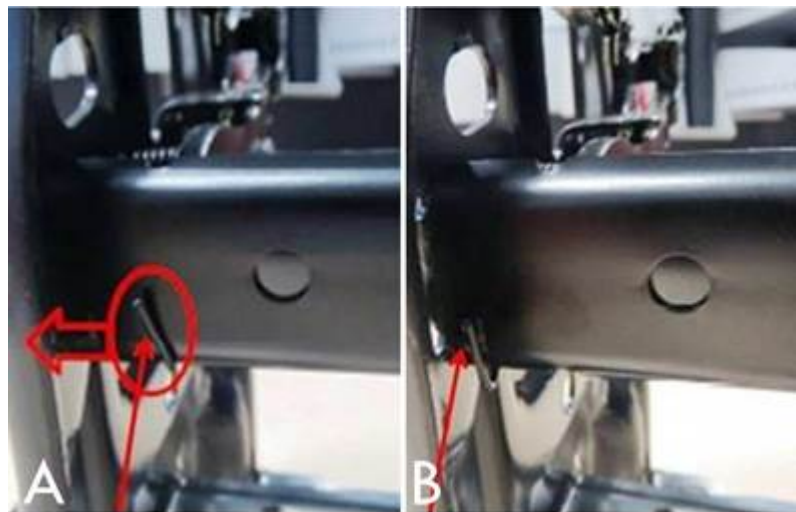
Figure 5. Spring in incorrect position (A). Spring in correct position (B).

3. Remove armrest and adjustment assembly according to the instructions in the Repair Manual.
4. Inspect the position of the bracket spring. Move the bracket spring on the housing in the direction indicated in the image at right (Figure 5, A). This will increase the tension of the spring.
