TECHNICAL BULLETIN

LTB00575NAS1

Horn Link Lead

LR2 (LF)

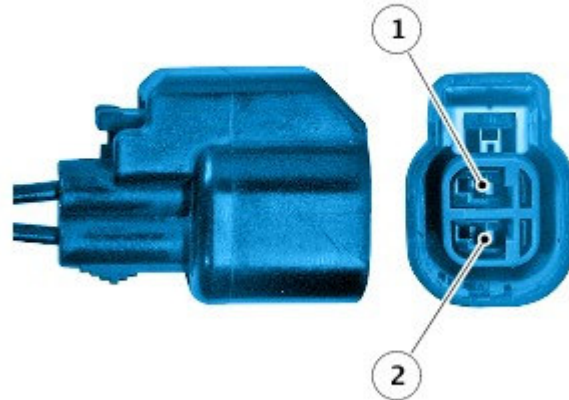
E159524

**NOTE: Replacement link lead wiring is not color coded; make sure connections are made to correct polarity.**

Place the new horn link lead next to the existing wiring harness; identify a suitable position to connect the new horn link lead to the existing wiring harness.
