TECHNICAL BULLETIN LTB00584NAS1 10 SEP 2013

SECTION: 501-00

Intermittent Steering Wheel Audio Control Switch Operation

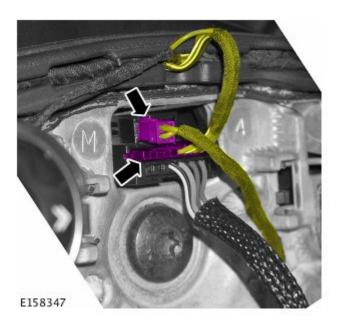
E158346

4. NOTE: Heated steering wheel option shown may not be present.

Disconnect and reconnect the clockspring and heated steering wheel (if fitted) connectors twice to clean the contact points.

• Leave the connector(s) disconnected.
