TECHNICAL BULLETIN
LTB00588NAS1
04 OCT 2013

SECTION: 204-06

Hydraulic Fluid 'Flow' or 'Hiss' Noise When Cornering

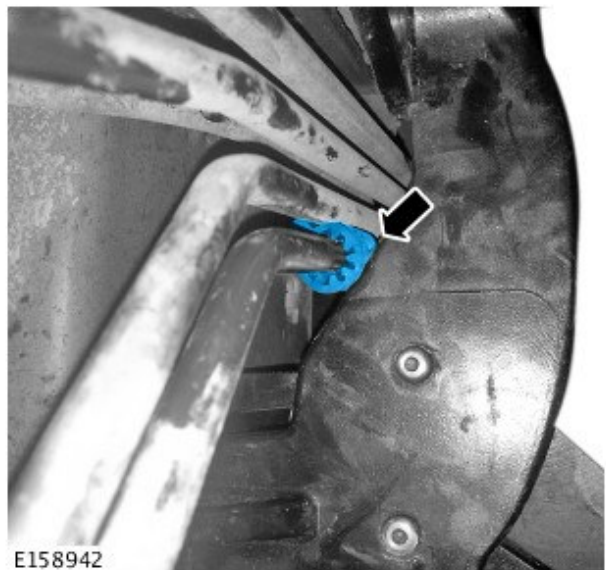
E158942

Cause: This may be caused by the side steps contacting the Dynamic Response System pipes.

3. Install rubber insulator at front bracket as shown.
