RECALL ACTION

Recall Action
Number: P035v2

Subject: Battery Positive Cable Clash with Dynamic Response System (DRS) Pipe [UKROW-SA]	Publication No.: P035v2
	Model: Range Rover Sport (LW) - TDV6 3.0L Diesel
	Model Years: 2014
	Vin Range: LW000016 - LW323768
	Date of Issue: 24/10/2013

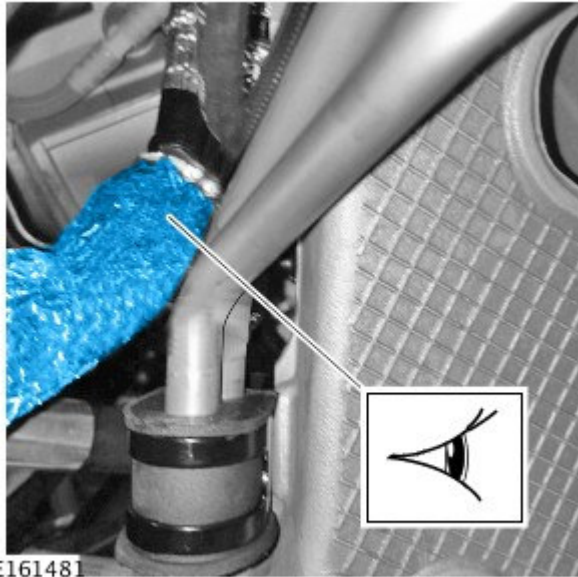
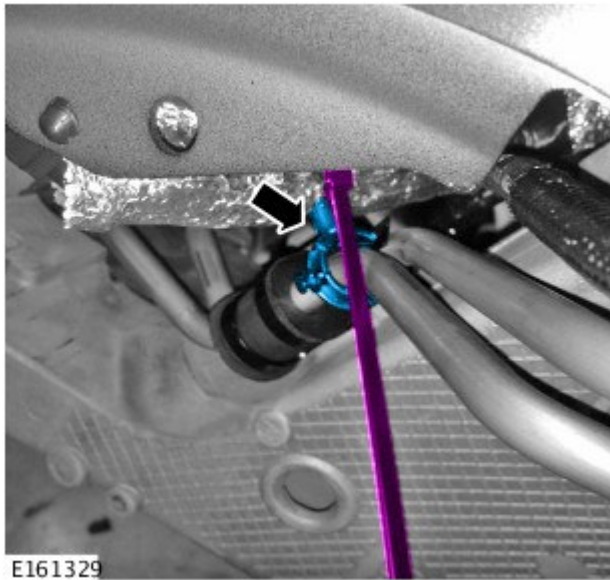
1. Remove the right front wheel arch liner (see TOPIX Workshop Manual, section 501-02).
2. Inspect the battery positive cable for any sign of damage to the cable insulation in the area of contact with the Dynamic Response Pipe.
 1. If there are signs of visible damage to the insulation, disconnect the battery and please hold the vehicle until further notice.
 2. If there are no signs of visible damage to the insulation, carry on from step 3.

3. Attach the cable tie to the battery positive cable but do not pull tight at this stage.

1. Attach the clip end to the dynamic response pipe.
