TECHNICAL BULLETIN
P037NAS1
12 DEC 2013

SECTION: 501-20B

Safety Recall: Airbag Warning Lamp Illuminated

Range Rover (LG)

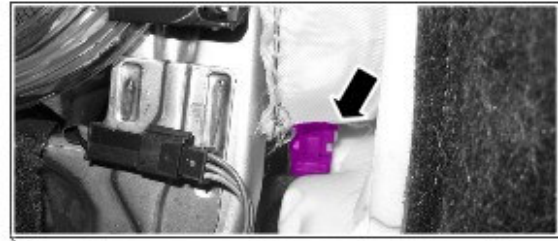
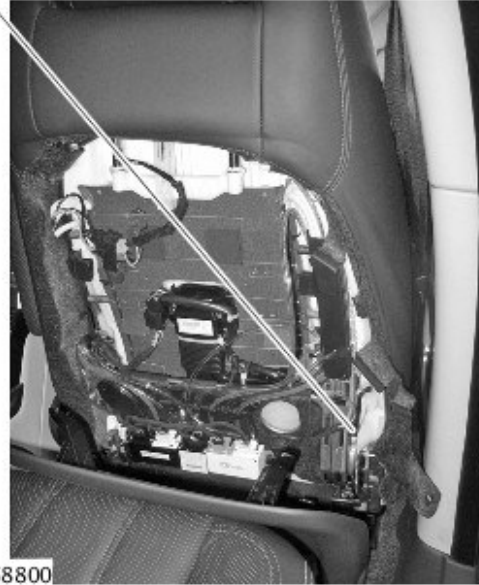
4. Locate the side airbag connector.

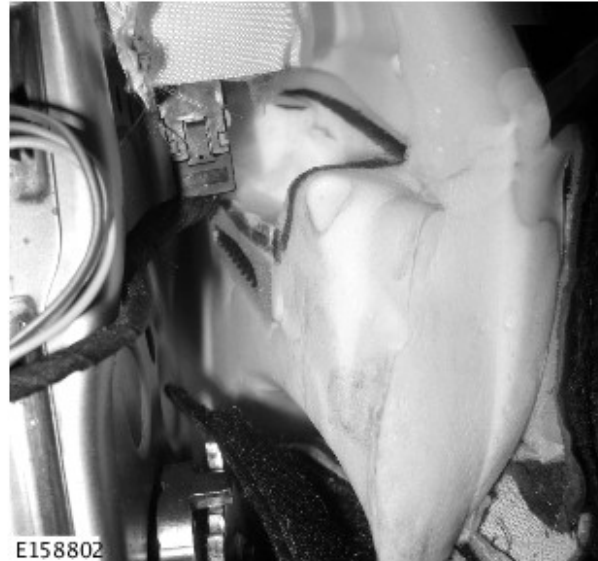
E158801

6. Seat foam cut back to the correct condition.
