TECHNICAL BULLETIN  
Q274NAS1  
09 OCT 2013

**SECTION: 501-03**

Service Action: Power Tailgate

**Range Rover (LG)**  
**Model Year:** 2013  
**VIN:** DA100499-DA113821

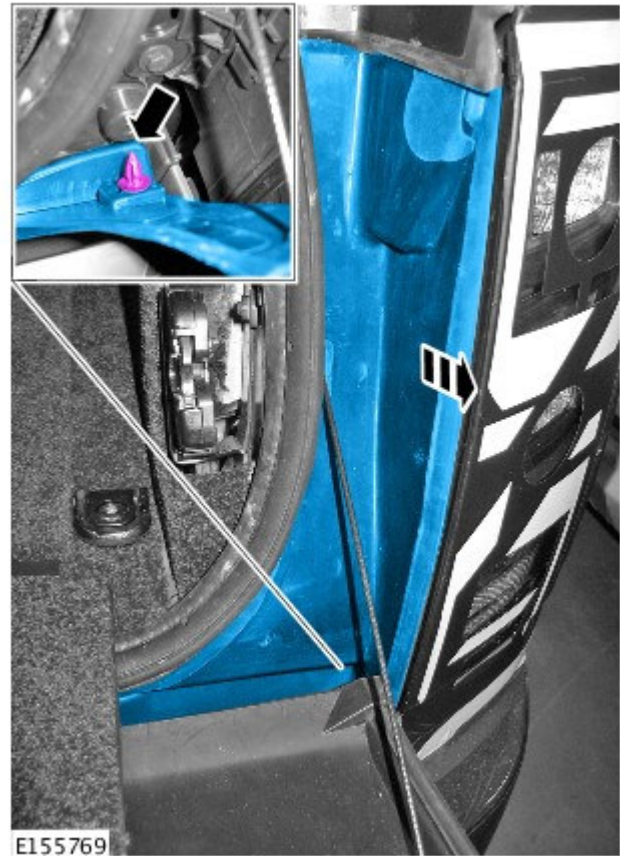
**Situation:** Vehicles within the listed VIN range may have a power tailgate which is not functioning as specified and the anti-trap is triggered by the lower drain trough due to insufficient retention.

14. Open the upper and lower tailgates.
15. Remove the right-hand trim panel.
  - Release the clip and remove trim panel.

**16.** Install the new right-hand trim panel.

**17.** Carry out the previous two steps to the left-hand trim panel.
