TECHNICAL BULLETIN Q332NAS1 18 DEC 2013

Service Action: Battery Retention

Range Rover Sport (LW)

Range Rover (LG)

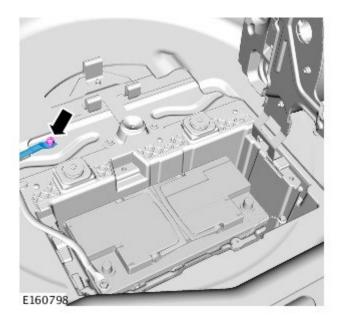
- 1. Remove the battery (see TOPIx Workshop Manual, section 414-01).
- **2.** Tighten the battery cable ground connection to 9 Nm.

3. CAUTION: Make sure that the surface is clean and free of foreign material.

Remove the inner battery tray.

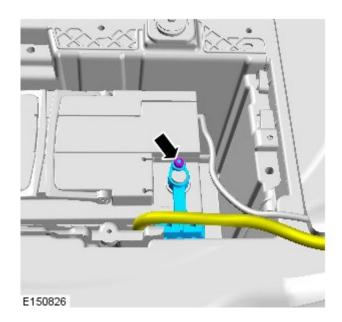
10. CAUTION: Make sure the cable is positioned parallel to the longest side of the battery and battery box.

CAUTION: Make sure the harness lies below the level of the carpet.

Install the battery positive cable as shown.

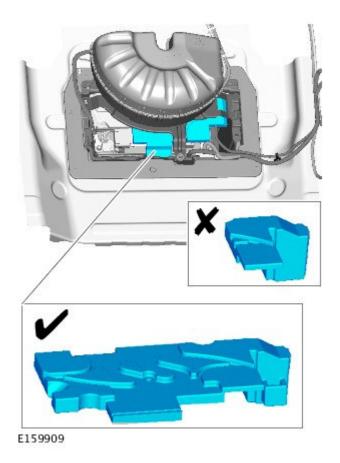
11. CAUTION: The correct Foam EPP pad must be present; without the correct pad, battery is not restrained and will lead to premature failure.

Check the correct foam pad is fitted.

- If the correct pad is fitted, continue to the next step.
- If the correct pad is not fitted, install the correct pad.
