Bluetooth and Phone Menu Icons Unavailable

Service Category Audio/Visual/Telematics

Section Cellular Communication

Some 2013 model year Lexus vehicles may exhibit a Bluetooth® inoperative condition where Phone and Bluetooth® menu icons are grayed out and cannot be accessed. A navigation firmware update has been developed to address this condition.

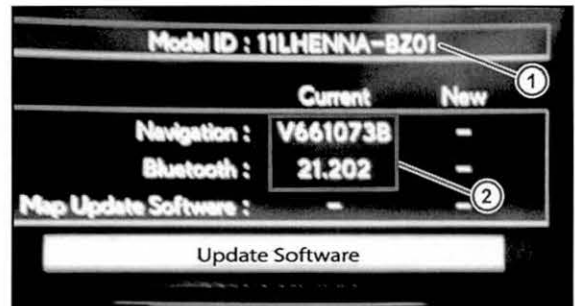
Figure 5.

1	ID Varies According to Vehicle
2	Current Version Is Displayed

7. Connect USB memory stick for the update.

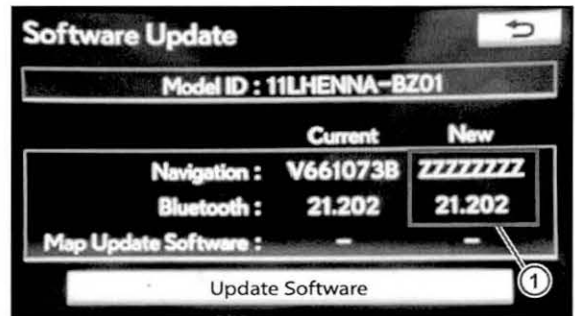
Figure 6.

1	Version to be Updated Is Displayed
---	------------------------------------

8. Press "Update Software".
