## Land Rover Touchscreen USB Programming Failure Recovery Advice v1.pdf

Reference	SSM65257
Models	Range Rover Sport / L320 LR3 / L319 LR2 / L359 Range Rover Evoque / L538 Range Rover (All New) / L405 LR4 / L319 Range Rover / L322
Title	Touch screen inoperative after USB software download failure - Recovery Advice
Category	Diagnostic Software Hardware
Last modified	07-May-2013 00:00:00
Symptom	000101 Diagnostic Concerns
Content	<p><b>Issue:</b></p> <p>The Touch Screen remains blank/inoperative after a USB software download failure, and subsequent attempts to repeat the programming procedure also fail.</p> <p>When unable to recover touch screen functionality using SDD, hardware must be removed and shipped to Mahwah for recovery using engineering tools.</p> <p><b>Cause:</b></p> <p>Root cause of the original USB download failure is unknown, and currently under investigation. Failure rates are reasonably low by percentage, but there has been a high volume of failures reported since the launch of the Q228 service action.</p> <p>Recovery of the touch screen using the special application titled "Entertainment - Touch screen recovery" may not be required, and in some cases could cause fur

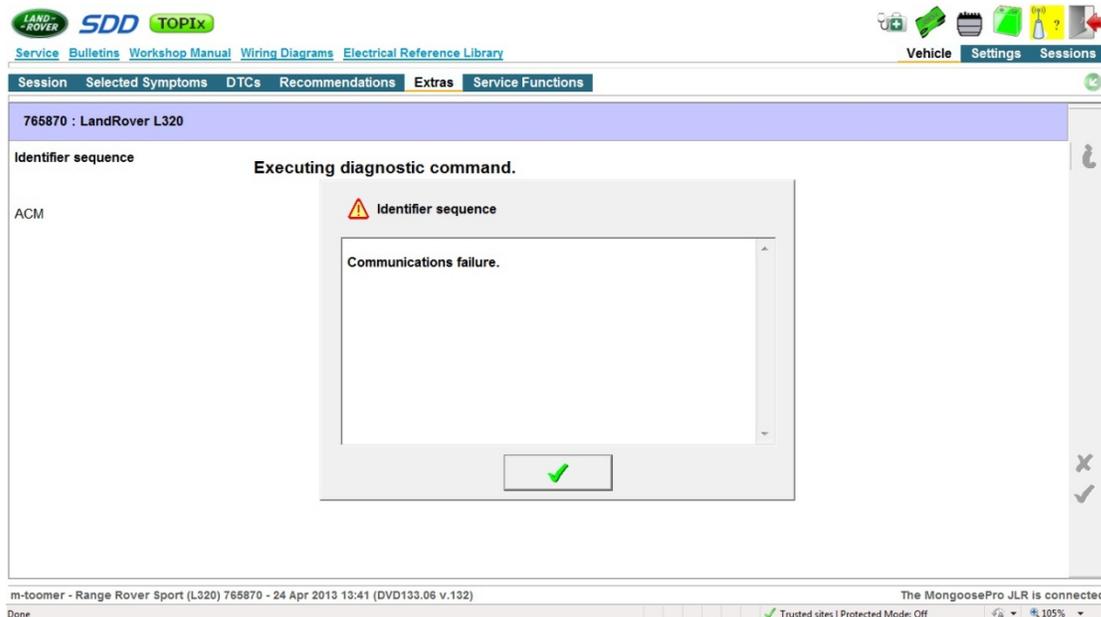
Under these recovery conditions, it is normal and expected to see the on-screen error message pictured below.

Tick past this error message and continue following these recovery instructions.

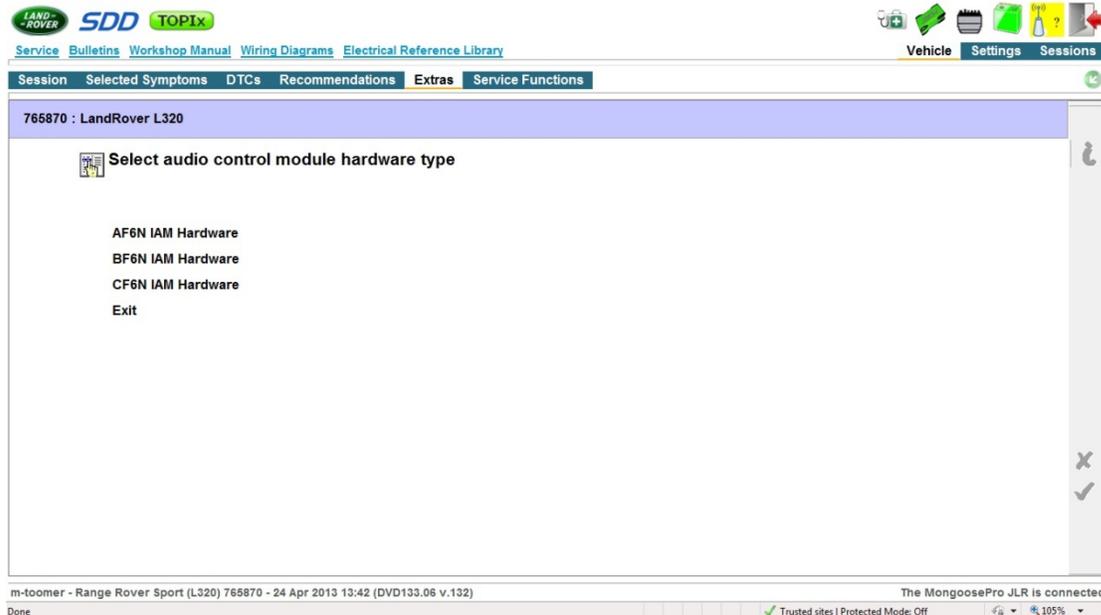
When prompted to “Select the audio control module hardware type”, you will need to select the option that corresponds to the Hardware Prefix number read from the ACM in Step 1.

**NOTE:** When making your selection on the following screen *IAM is the alternate acronym for ACM*, select the IAM hardware that matches the ACM prefix.

After making the correct IAM hardware selection, click the green tick to continue.
