## EPB DTC CODES C2007-11 C2008-11 ver2.docx

SSM66897
	LR2 / L359 Range Rover Evoque / L538
Title	RR Evoque and Freelander 2: EPB DTC Codes C2007-11 and C2008-11
Category	Chassis
Last modified	19-Aug-2013 00:00:00
Symptom	302000 Parking Brake System
Content	<b>Issue:</b> Customers have reported warning lamp illumination and Park Brake Activation / De-Activation functionality issues with related DTCs C2007-11 or C2008-11. <b>Cause:</b> JLR Engineering are continuing to investigate root cause of the issue. <b>Action:</b> In order to implement a Right First Time repair, dealers are instructed to follow the attached process for root cause investigation should the above DTCs be observed. Following analysis, dealers are requested to report the causal part for the DTC flag via an EPQR.

DEALER SMM INFO FOR EPB DTC CODES C2007-11 AND C2008-11.

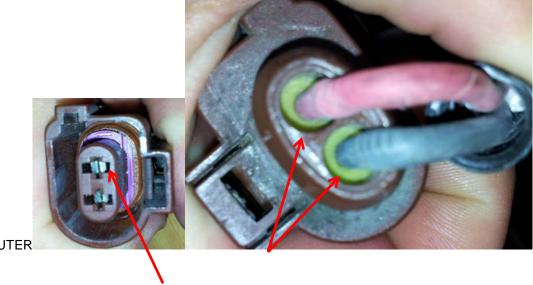
- 1) CHECK FUSE FOR AFFECTED SIDE.
- CHECK ECU GROUND CONNETIONS TO VEHICLE CHASSIS (STUD G4D152-1) (CHECK FOR CORROSION/SCREW TORQUE/LOOSE CONNECTION/PAINT).
- 3) REMOVE THE AFFECTED CALIPER ACTUATOR AND SWAP WITH THE UN AFFECED CALIPER ACTUATOR (REFER TO TOPIX FOR REMOVAL AND REFITMENTMENT PROCESS), ACTUATE THE EPB VIA SWITCH. CHECK IF THE FAULT FOLLOWS THE ACTUATOR. IF IT DOES THE ACTUATOR IS FAULTY. IF IT DOES NOT THE FAULT IS LIKELY TO BE IN THE LINK LEAD/CONNECTORS ON THE FAULTY SIDE.
- 4) CHECK THE LINK LEAD, CHECK THE PINS FOR CORROSION ON BOTH ACTUATOR AND LINK LEAD. CHECK THE SEALS ARE PRESENT BOTH INNER AND

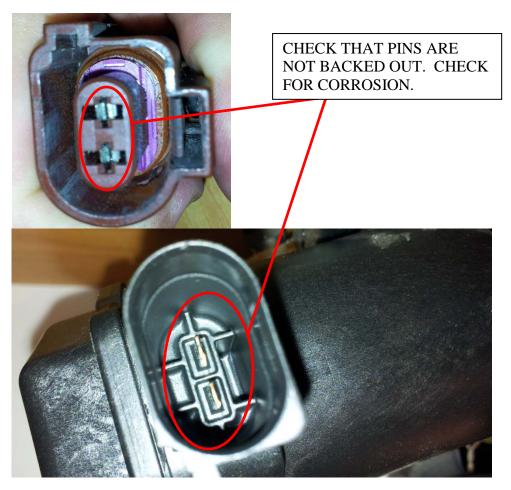
LINK LEAD SEALS - INNER AND OUTER. CHECK FOR PRESENCE AND DAMAGE.

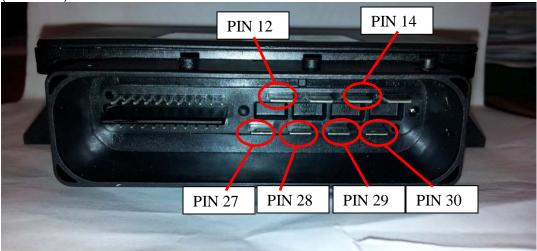
- 5) REMOVE LINK LEAD AND CAREFULLY CHECK FOR ANY VISIBLE SIGNS OF DAMAGE (CHAFING, PINCHING AND STRETCHING).
- 6) REMOVE EPB ECU (REFER TO TOPIX) AND TEST THE RESISTANCE BETWEEN THE MOTOR LINES AND GND ON THE ECU. USING PINS 12 OR 27 (MULTIMETER POSTIVE) TO PIN 28 (GND) FOR THE RIGHT CHANNEL (2007-11). USING PINS 14 OR 29 (MULTIMETER POSTIVE) TO PIN 30 (MULTIMETER G ND) FOR THE LEFT CHANNEL (C2008-11). THE RESISTANCE SHOULD BE 12.7 K OHM +/- 0.7 K OHM

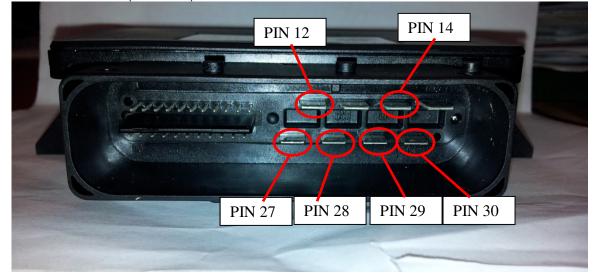
- 1) CHECK FUSE FOR AFFECTED SIDE.
- 2) CHECK ECU GROUND CONNETIONS TO VEHICLE CHASSIS (STUD G4D152-1) (CHECK FOR CORROSION/SCREW TORQUE/LOOSE CONNECTION/PAINT).
  - 5) REMOVE EPB ECU (REFER TO TOPIX) AND TEST THE RESISTANCE BETWEEN THE MOTOR LINES AND GND ON THE ECU. USING PINS 12 OR 27 (MULTIMETER POSTIVE) TO PIN 28 (GND) FOR THE RIGHT CHANNEL (2007-11). USING PINS 14 OR 29 (MULTIMETER POSTIVE) TO PIN 30 (MULTIMETER GND) FOR THE LEFT CHANNEL (C2008-11). THE RESISTANCE SHOULD BE **12.7 K OHM +/- 0.7 K OHM**

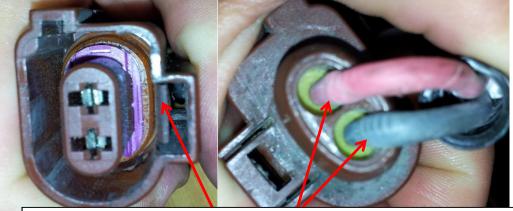
3) REMOVE THE AFFECTED CALIPER ACTUATOR AND SWAP WITH THE UN AFFECED CALIPER ACTUATOR (REFER TO TOPIX FOR REMOVAL AND REFITMENTMENT PROCESS), ACTUATE THE EPB VIA SWITCH. CHECK IF THE FAULT FOLLOWS THE ACTUATOR. IF IT DOES THE ACTUATOR IS FAULTY. IF IT DOES NOT THE FAULT IS LIKELY TO BE IN THE LINK LEAD/CONNECTORS ON THE FAULTY SIDE. 4) CHECK THE LINK LEAD, CHECK THE PINS FOR CORROSION ON BOTH ACTUATOR AND LINK LEAD. CHECK THE SEALS ARE PRESENT BOTH INNER AND OUTER

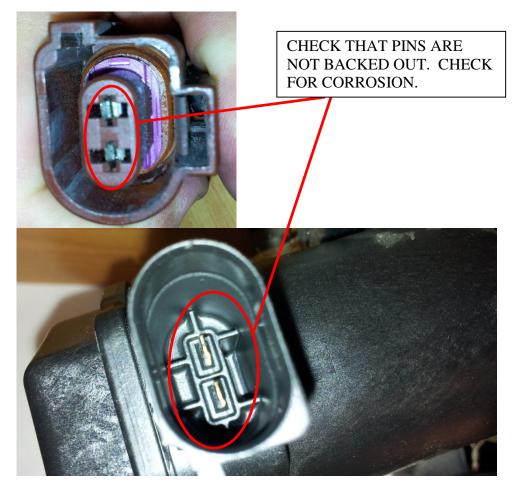
LINK LEAD SEALS – INNER AND OUTER. CHECK FOR PRESENCE AND DAMAGE.

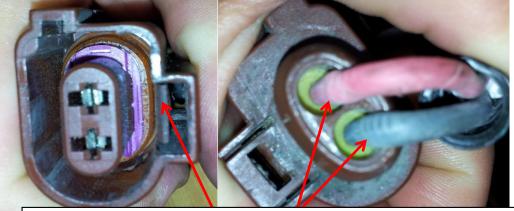
- 1) CHECK FUSE FOR AFFECTED SIDE.
- 2) CHECK ECU GROUND CONNETIONS TO VEHICLE CHASSIS (STUD G4D152-1) (CHECK FOR CORROSION/SCREW TORQUE/LOOSE CONNECTION/PAINT).
- 3) REMOVE THE AFFECTED CALIPER ACTUATOR AND SWAP WITH THE UN AFFECED CALIPER ACTUATOR (REFER TO TOPIX FOR REMOVAL AND REFITMENTMENT PROCESS), ACTUATE THE EPB VIA SWITCH. CHECK IF THE FAULT FOLLOWS THE ACTUATOR. IF IT DOES THE ACTUATOR IS FAULTY. IF IT DOES NOT THE FAULT IS LIKELY TO BE IN THE LINK LEAD/CONNECTORS ON THE FAULTY SIDE.
- 4) CHECK THE LINK LEAD, CHECK THE PINS FOR CORROSION ON BOTH ACTUATOR AND LINK LEAD. CHECK THE SEALS ARE PRESENT BOTH INNER AND OUTER

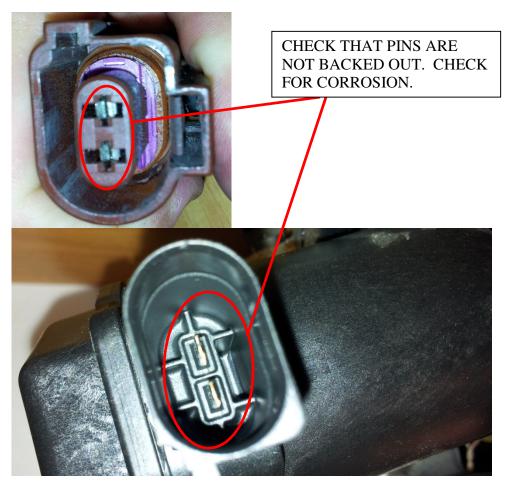
LINK LEAD SEALS – INNER AND OUTER. CHECK FOR PRESENCE AND DAMAGE.

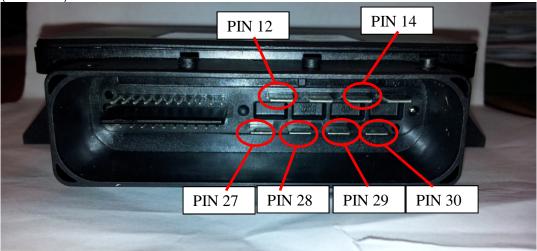
- 5) REMOVE LINK LEAD AND CAREFULLY CHECK FOR ANY VISIBLE SIGNS OF DAMAGE (CHAFING, PINCHING AND STRETCHING).
- 6) REMOVE EPB ECU (REFER TO TOPIX) AND TEST THE RESISTANCE BETWEEN THE MOTOR LINES AND GND ON THE ECU. USING PINS 12 OR 27 (MULTIMETER POSTIVE) TO PIN 28 (GND) FOR THE RIGHT CHANNEL (2007-11). USING PINS 14 OR 29 (MULTIMETER POSTIVE) TO PIN 30 (MULTIMETER G ND) FOR THE LEFT CHANNEL (C2008-11). THE RESISTANCE SHOULD BE 12.7 K OHM +/- 0.7 K OHM
