Reference	SSM67737
Models	Range Rover Sport / L494 Range Rover (All New) / L405
Title	Earth fixings to Body Studs Potentially Loose (L405 & L494)
Category	Electrical
Last modified	26-Aug-2013 00:00:00
Symptom	203000 Basic Electrical
Content	<p><b>ISSUE:</b> Variety of symptoms relating to the electrical system, including (but not exclusively) non start, multiple warning lights illuminated, Instrument pack not operating or HLDF ( High Level Display Front) not lighting up.</p> <p><b>CAUSE:</b> The root cause is under investigation and may be that the fixing for an Earth stud is not clamping the earth eyelets with the required force.</p> <p><b>ACTION:</b> If during diagnosis an earth fixing is found to be loose:</p> <p><b><u>Do not physically disturb the joint until you have:</u></b></p> <ol style="list-style-type: none"> <li>1. Take photos to show the condition of the exposed thread</li> <li>2. Check if the Anti- Rotation device is clamped against the BIW or another object (ie harness) and take a photo</li> <li>3. There should be a paint mark on the anti-rotation device, or a china graph pencil mark on the heat shrink sleeve primary of the battery earth (G4D178). Take photo to confir

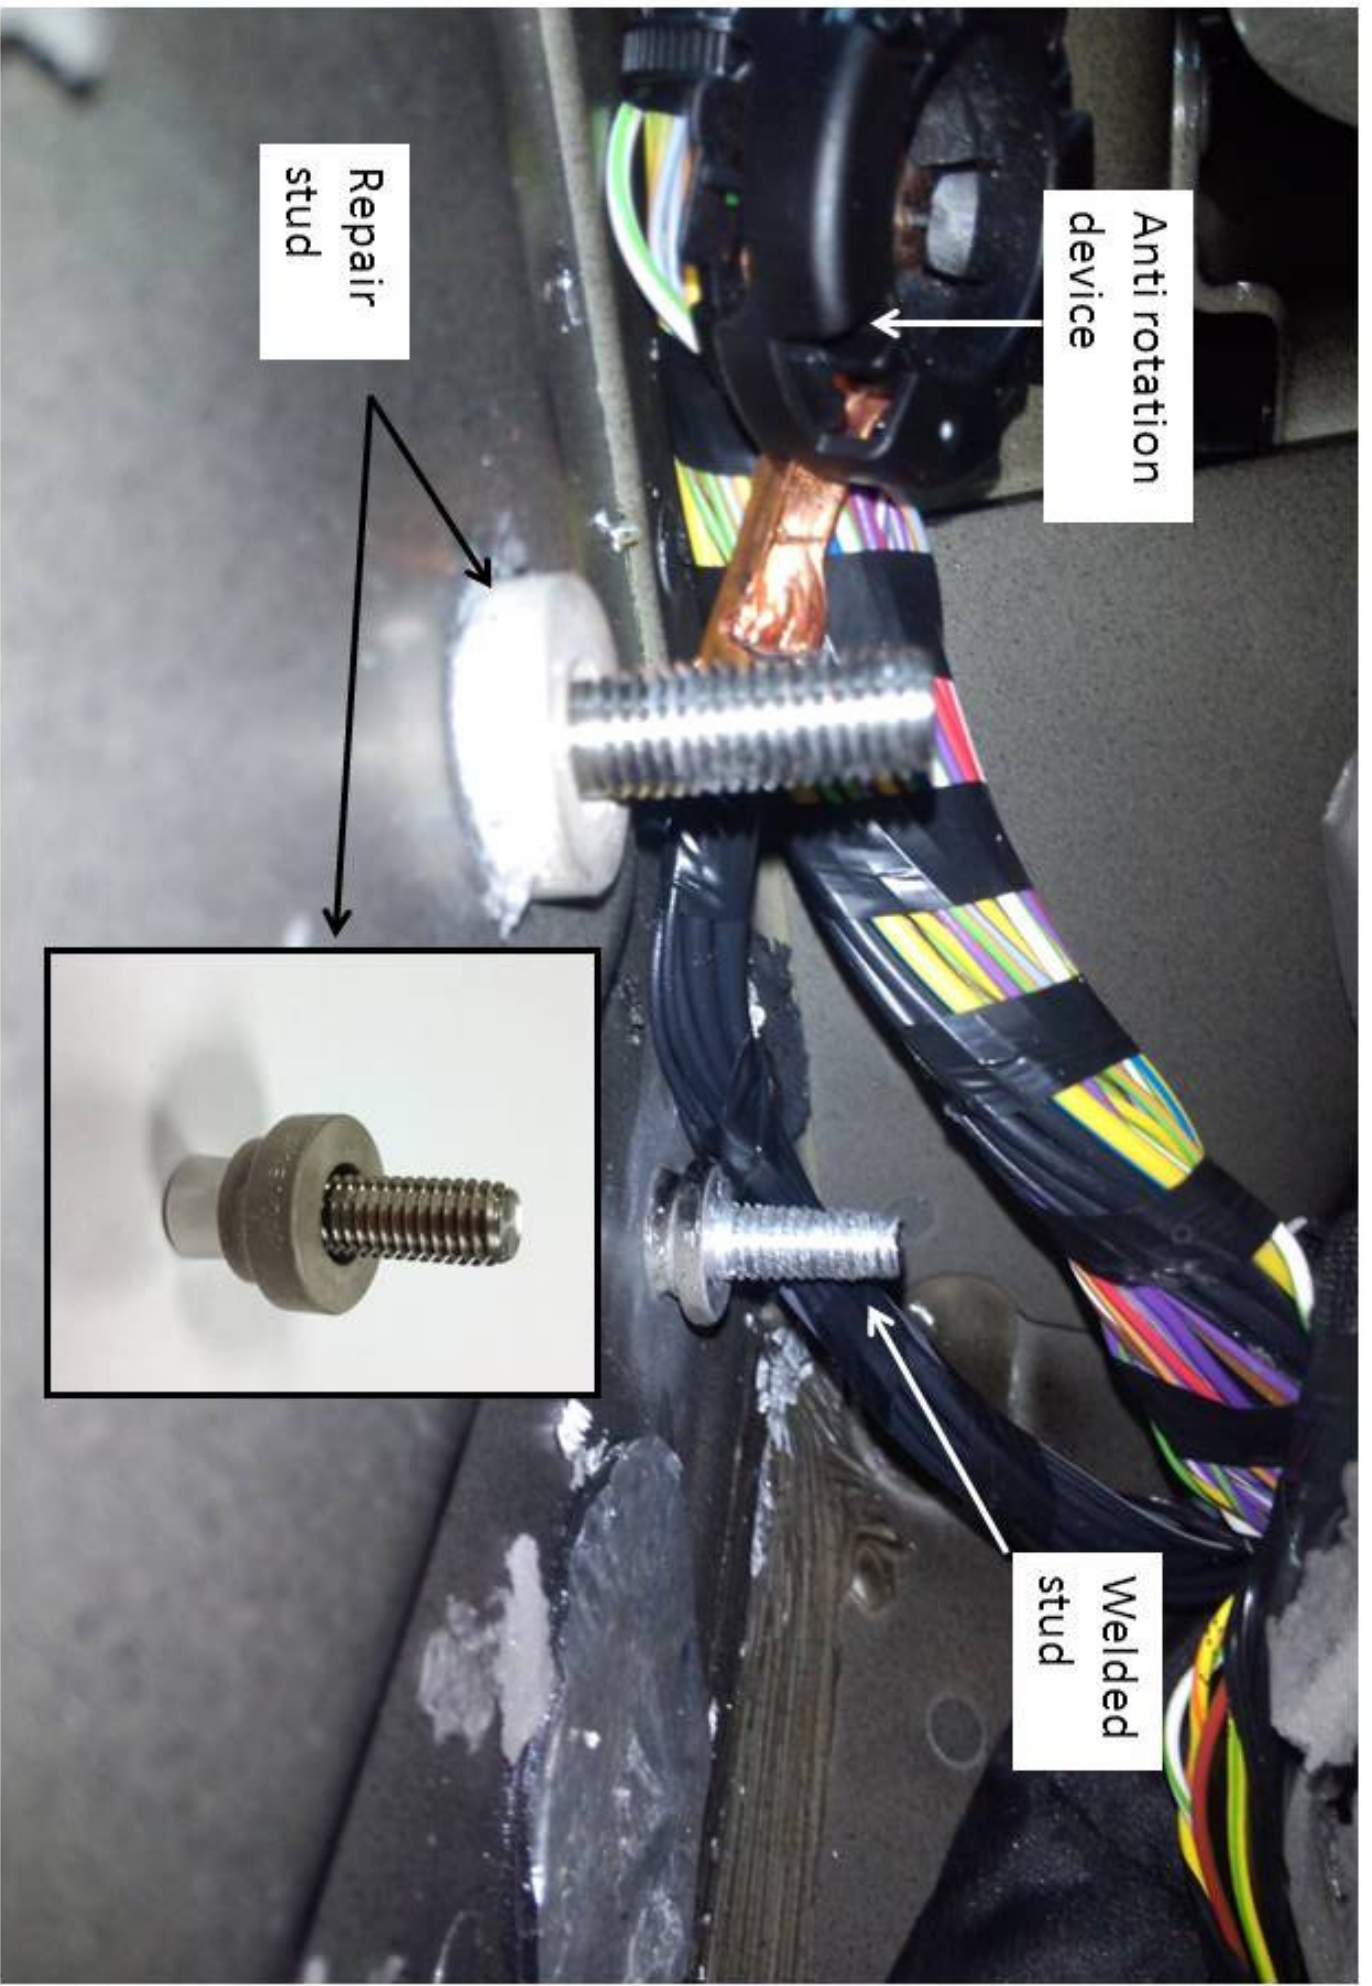
Anti rotation device

Welded stud

Repair stud
