Technical Service Bulletin

34, 37 Grinding or wheel bearing type noises from front when accelerating or at constant speed

34 13 13 2028650/2 January 15, 2013. Supersedes Technical Service Bulletin Group 34 number 12-08 dated February 21, 2012 for reasons listed below.

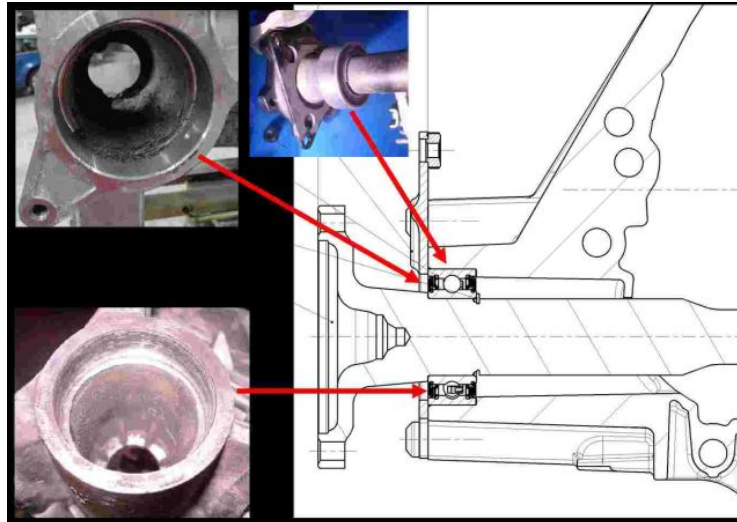
The ball bearing for the left flange shaft spins in the gearbox housing because of a gap between the outer bearing ring and the support bracket. This can result in grinding marks and swarf (Figure 1, Figure 2).

Figure 1. Grinding marks and swarf in gearbox housing.

Try to reproduce the customer complaint so that it can be clearly assigned to this TSB by removing the support bracket and checking for wear marks. If wear marks are present as shown in Figure 1 or Figure 2 above, follow checks and repair instructions below:

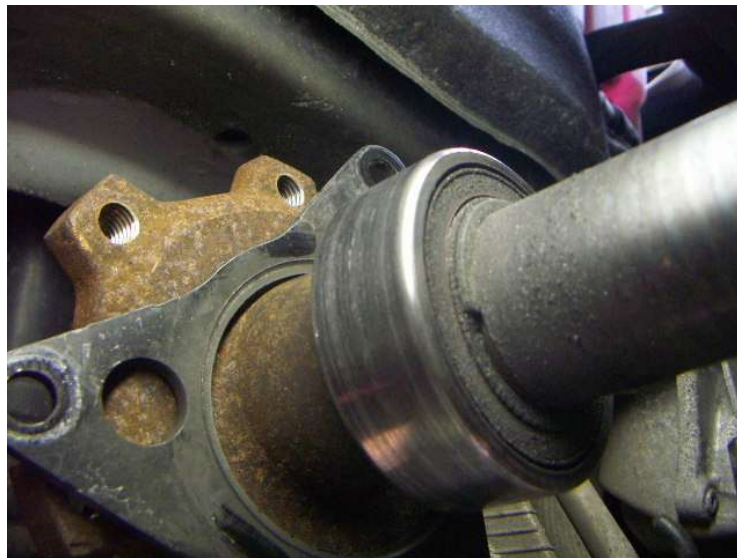
Figure 2. Grinding marks and swarf on flange housing and bearing.

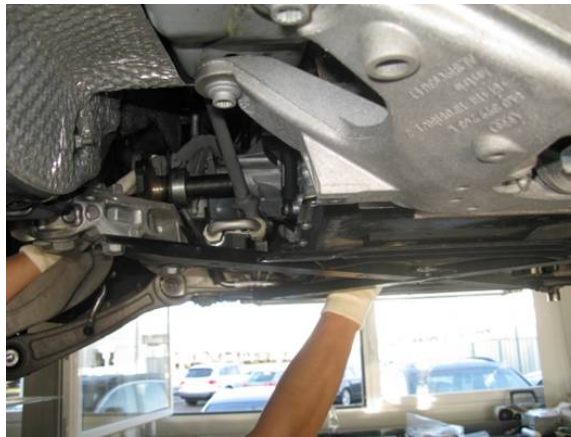
Figure 3. Pulling out the flange shaft.

6. Pull the left flange shaft out of the gearbox (according to the repair manual) (Figure 3). Support the flange shaft through the lower opening on the gearbox (service flap) to avoid damaging the oil seal between differential and gearbox housing (Figure 4).

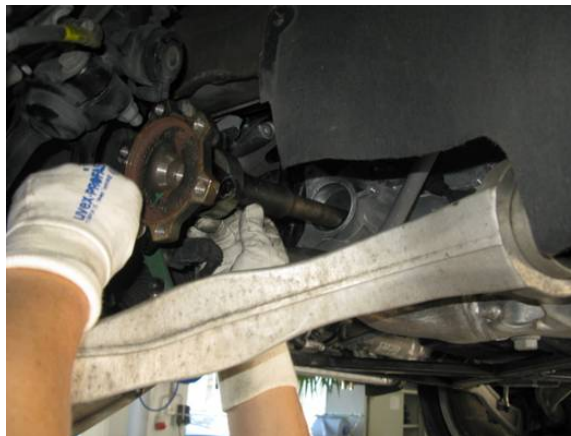
Figure 4. Supporting the flange shaft.

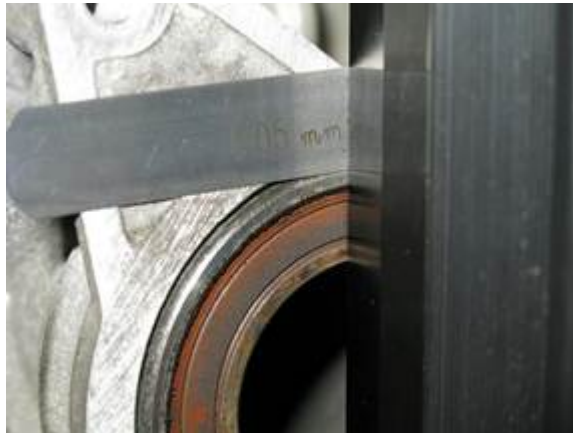
Figure 5. Bearing example.

The following steps assist in determining how many shims must be fitted between bearing and gearbox housing to make the bearing extend out from the case a minimum of 0.5mm to 0.8 mm (Figure 5).

Tip: Bearing in Figure 5 is only for demonstration purposes. Always measure using a new bearing.

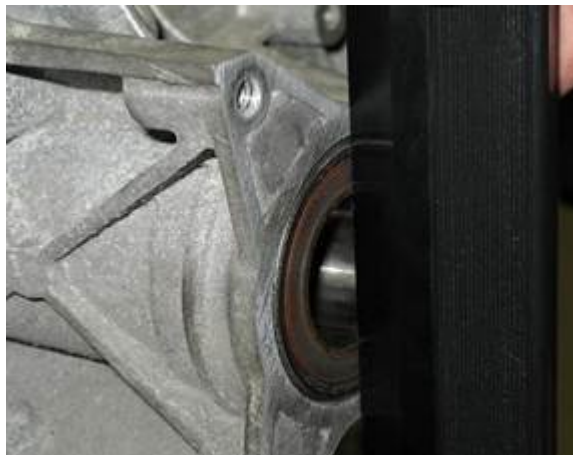
Figure 6. Apply straightedge on gearbox housing/bearing.

1. Use size 600 grit sandpaper to remove any corrosion or dirt on the gearbox flange surface. Do not clean the bearing carrier.
2. Measure whether the gap between bearing and gearbox housing is flush or extended from case.
3. Use a straightedge on two different positions on the bearing and on the gearbox housing (this leads to four measuring positions) (Figure 6).

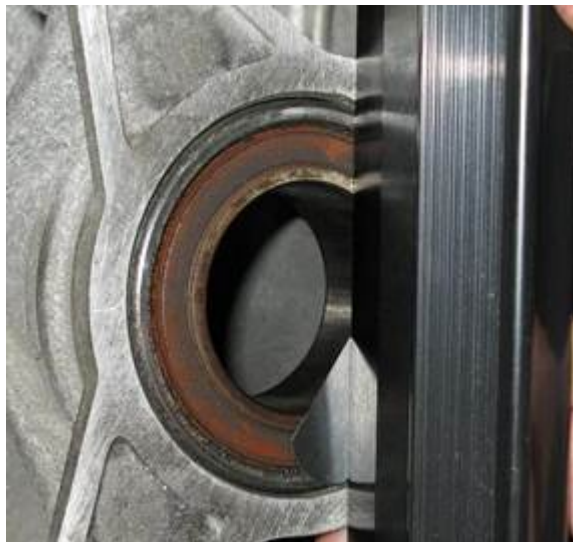
Figure 7. Measuring gap

4. Determine the value with a feeler gauge on four different points (Figure 7).

Tip: Bearing in Figure 7 is only for demonstration purposes. Always measure using new bearing.

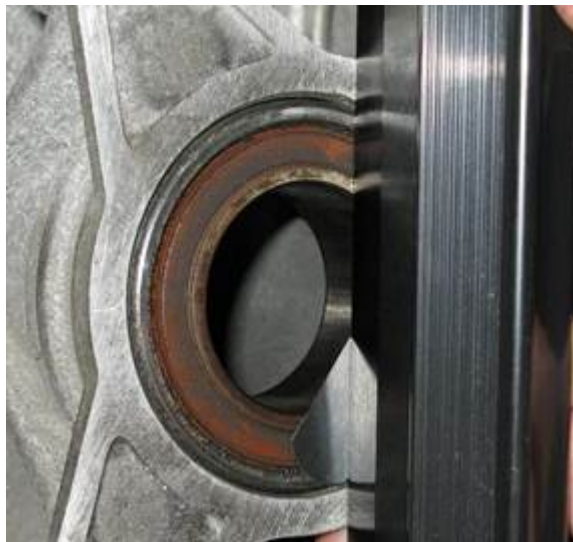
Measured values: Top 0.10 mm, bottom 0.15 mm, left 0.15 mm, right 0.10 mm

$$\begin{aligned} & - 0.15 \text{ mm} \\ + & 0.30 \text{ mm} \quad \text{thickness of 1st shim} \\ = & 0.15 \text{ mm} \\ + & 0.30 \text{ mm} \quad \text{thickness of 2nd shim} \\ = & 0.45 \text{ mm} \\ + & 0.30 \text{ mm} \quad \text{thickness of 3rd shim} \\ = & 0.75 \text{ mm} \quad \text{minimum is reached} \\ & (0.5- 0.8 \text{ mm}) \end{aligned}$$

Figure 8. Determine the below flush value.

Three shims are needed.

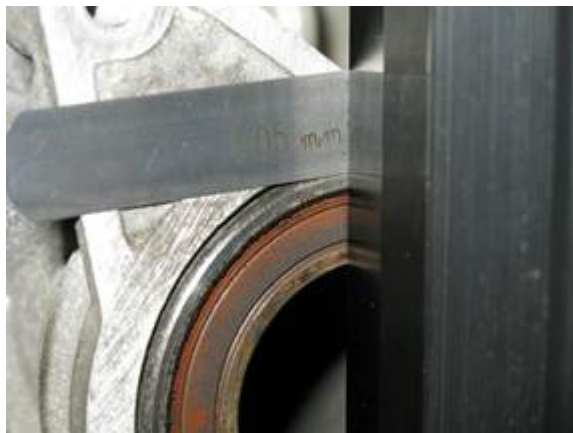
Although the bearing may extend from the case as shown, the distance may not be enough to hold the bearing tight. Measure as follows to determine and correct.

Measured values: Top 0.10 mm, bottom 0.15 mm, left 0.10 mm, right 0.10 mm

Figure 9. Determine the extended value.

Two shims are needed.

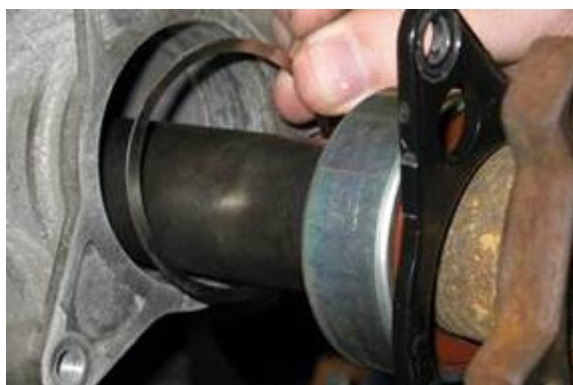
Figure 10. Position of shims.

2. Clean the flange shaft with a fluff-free cloth and slightly lube the shaft at the seal contact area using **G 052128A1**.
3. Install the shims and feed the shaft back through the opening of the lower gearbox side with appropriate support, taking care not to damage the seal (Figure 10).
4. Be sure to replace the support bracket bolts.
