Technical Service Bulletin

34 - 6th gear jumps out - 0B1/0B2 gearbox

34 13 14 2026719/3 January 30, 2013. Supersedes Technical Service Bulletin Group 34 number 11-04 dated June 21, 2011 for reasons listed below.

Model(s)	Year	VIN Range	Vehicle-Specific Equipment
A4	2010-11	All	2.0L with manual transmission
A5	2010-11	All	2.0L with manual transmission

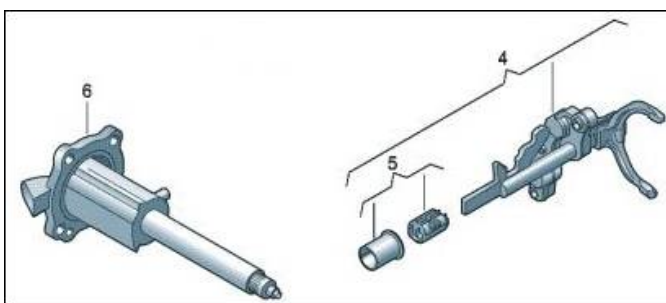
Figure 1. Shift fork and gear shift unit

The transmission jumps out of 6th gear.

Improved 5th and 6th shift fork and gearshift unit.

4. Replace the 5th -6th gear shift fork and ball sleeve (*Item 4 and 5, Figure 1*) and the gear shift unit (*Item 6 Figure 1*) per instructions in *ELSA: Transmission*>> *Manual Transmission Internal Components*>> *34 Controls, Housing*>> *Disassembly and Assembly*>> *Transmission, Assembly Sequence AND 35 Gears, Shafts*>> *Disassembly and Assembly*>> *Shift Fork Group, input shaft*.

Tip: When replacing the shift fork and ball sleeve, **no** further disassembly of input shaft is required.
