# Technical Service Bulletin

## 35 Gearbox malfunction message in cluster (DTC P17D800 or P179D00)

35 13 10 2030477/3 May 7, 2013. Supersedes Technical Service Bulletin Group 35 number 12-06 dated December 7, 2012 for reasons listed below.

Model(s)	Year	VIN Range	Vehicle-Specific Equipment
S4, S5	2010-2012	All	S-Tronic 7 speed transmission

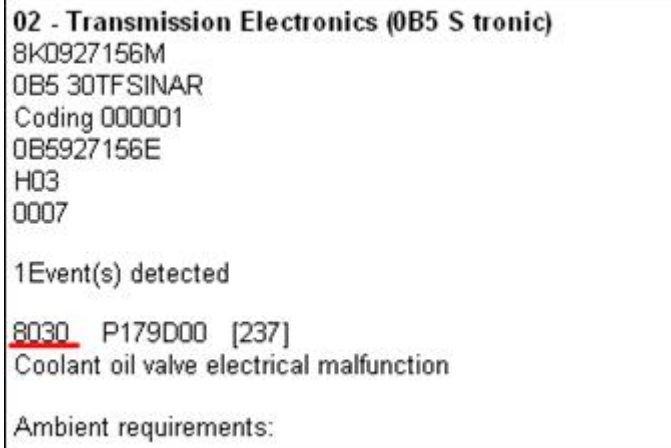
**Tip:** Fault codes and DFCC codes must match *exactly* or this TSB should not be followed. The DFCC is the 4-6 digit code that is typically listed before the fault code (Figure 1).

**Figure 1.** DFCC 4-6 digit code listed before the fault code, underlined in red.
