TECHNICAL BULLETIN
LTB00304NAS8
31 MAY 2013

Fuel Gauge Operation / DTC U0128-00 Stored

LR4 (LA)	Model Year:	2010-2013
	VIN:	AA510178-DA656034
Range Rover Sport (LS)	Model Year:	2010-2013
	VIN:	AA212145-DA790997

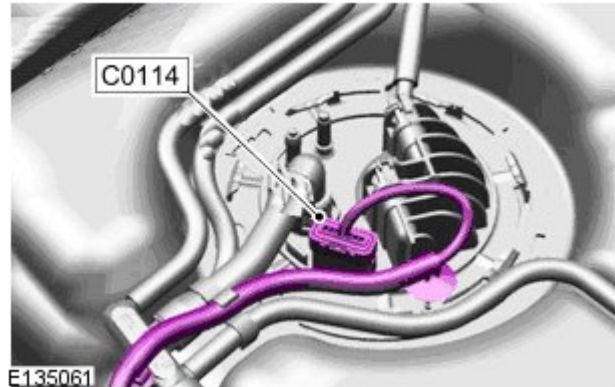
13. The first area to check before commencing any further work is the vehicle harness to fuel tank connection. A poor connection may exist where the harness plugs into the flange.

1. To test, with the ignition turned 'OFF' and connector in place, pull the connector upwards to give a worse case scenario connection situation.

2. Turn the ignition 'ON'.

- does the gauge drop to zero?

3. Repeat several times.

- If fault is found, remove connector and ensure pin connections are not loose and that they are correctly retained in the connector housing.
- If no fault can be found, confirm the connector is fitted and pushed fully home and continue with further diagnostics as detailed TOPIX Workshop Manual section 310-01C / D: Fuel Tank and Lines Diagnosis and Testing.

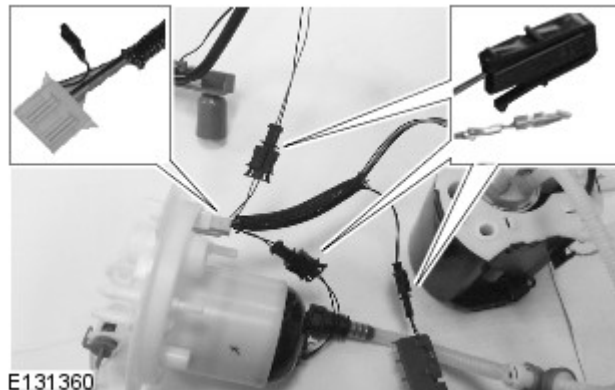
14.

**NOTE: Typical in-tank fuel module and sender components; not all derivatives will have the same number of connectors.**

Backed-out pin/wire could be any of the wires on the connector assembly; all **must** be checked.
