TECHNICAL BULLETIN
LTB00384NAS3
22 JAN 2013

Headlamp 'Blooming'

Range Rover (LM) - All with Adaptive Xenon Lamps

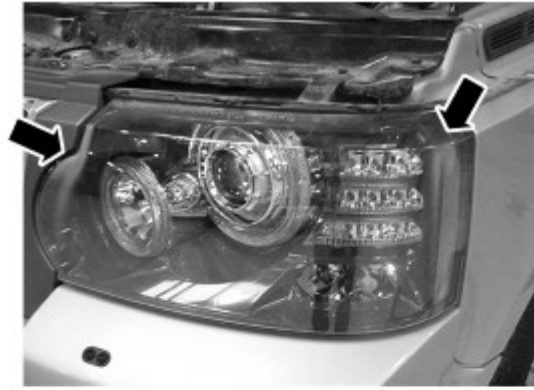
E149508

Situation: A visible discoloration on the inside of the headlamp lens may be evident.

Cause: This may be caused by silicon discharge within the headlamp assembly.

- NOTE: Example of the locations of the headlamp blooming issue.**

**NOTE: Only replace the headlamp that has the fault condition. Do not automatically replace as a pair.**

Replace affected headlamp assembly / assemblies (TOPIx Workshop Manual section 417-01).
