TECHNICAL BULLETIN
LTB00507NAS1
07 FEB 2013

Loadspace Cover-To-Tailgate Contact Repair

Range Rover Evoque (LV)

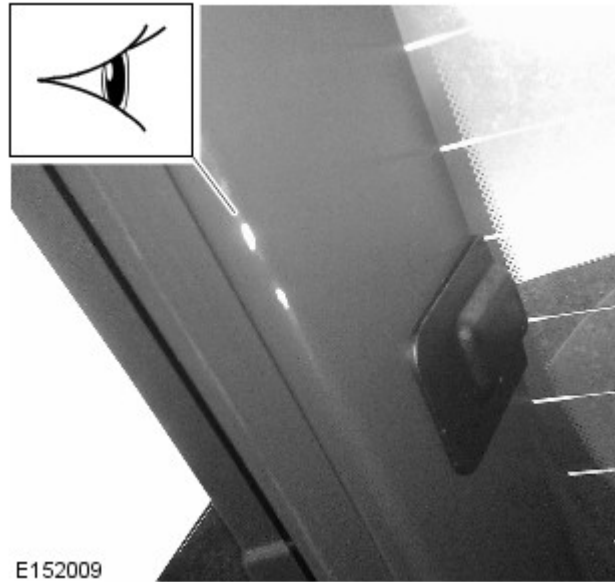
Situation: The loadspace cover may contact the tailgate inner trim, resulting in wear to both parts.

1. Identify damaged area.

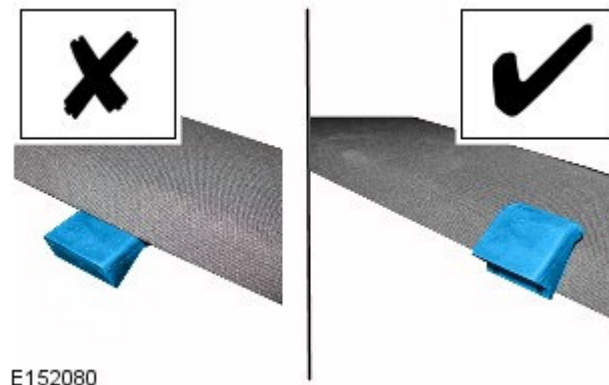
Cause: This may be caused when the loadspace cover is held above its design location.

**NOTE: The tangs shown are those which are part of the tailgate.**

Loadspace cover in the possible foul condition ('X') and also in the correct position ('tick').

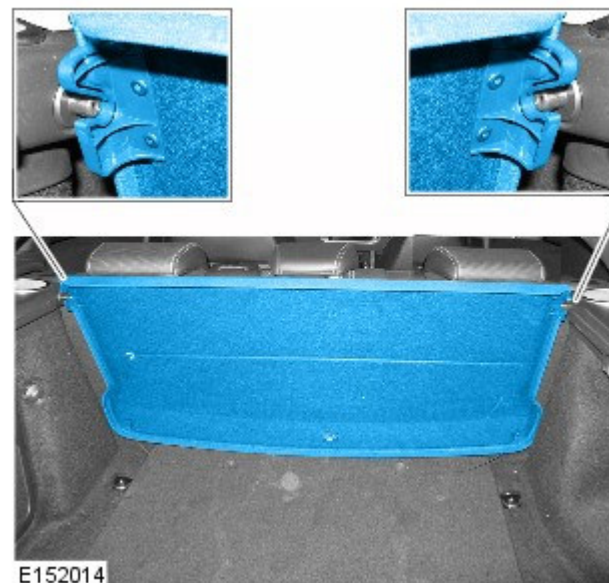
**NOTE: The loadspace cover may become incorrectly seated if the loadspace area is overloaded. Should this occur, advise the owner about the loadspace cover stow position shown. Refer to Owner's Handbook for further information.**

Loadspace cover shown in stowed position.
