TECHNICAL BULLETIN
LTB00557NAS1
27 SEP 2013

Knock Sound From Front Suspension

Range Rover (LG)

Model Year: 2013-2014

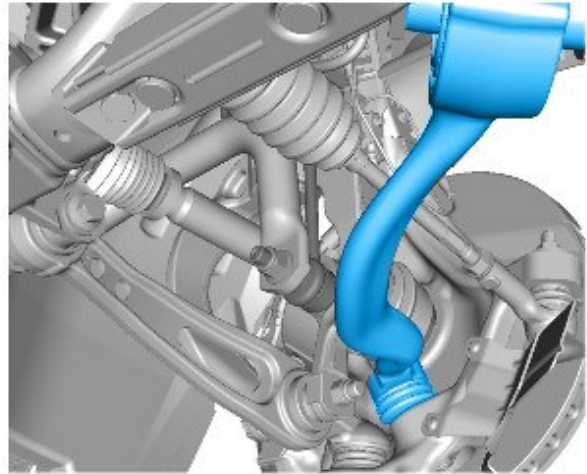
P3 Lower Control Arm to Frame

**NOTE: Minimum Torque: 190Nm (refer to table 2).**

- If the measured torque is less than the minimum residual torque shown, the fixing should be replaced with new and torque with reference to TOPIx 204-01: Front Suspension.

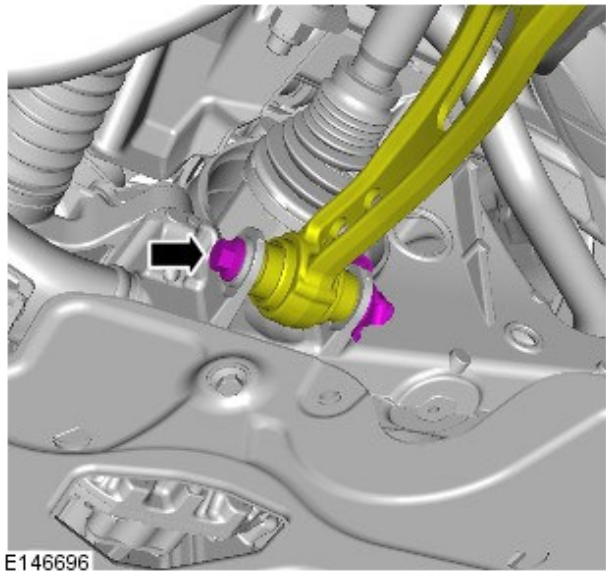
P4 Lower Control Arm to Frame

**NOTE: Minimum Torque: 190Nm (refer to table 2).**

- If the measured torque is less than the minimum residual torque shown, the fixing should be replaced with new and torque with reference to TOPIx 204-01: Front Suspension.

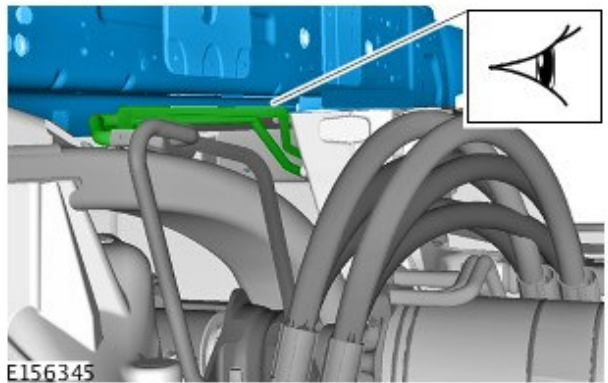
16. Front Pipe Set to Subframe

- Check that the rubber buffer is fitted to the hydraulic pipe. Ensure that there is not a hard foul between the hydraulic pipe and the sub frame.

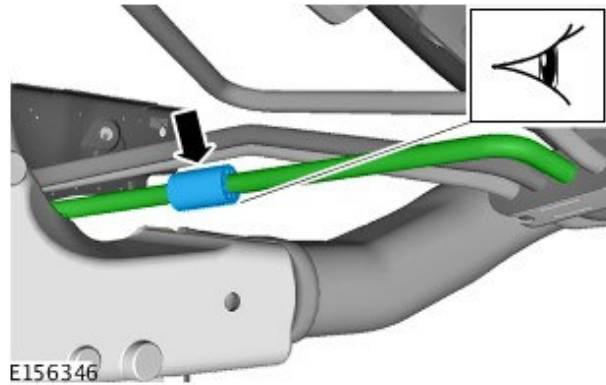
17. Return Hose to Longitudinal

- Check that the rubber buffer is fitted and that there isn't a hard foul between the return pipe/hose and the underside of the longitudinal.
