NUMBER: 08-025-13

RHW And RHP Navigation System Does Not Show The Proper Vehicle Location

2011 (RT) Voyager/Grand Voyager/Town and Country (International only)

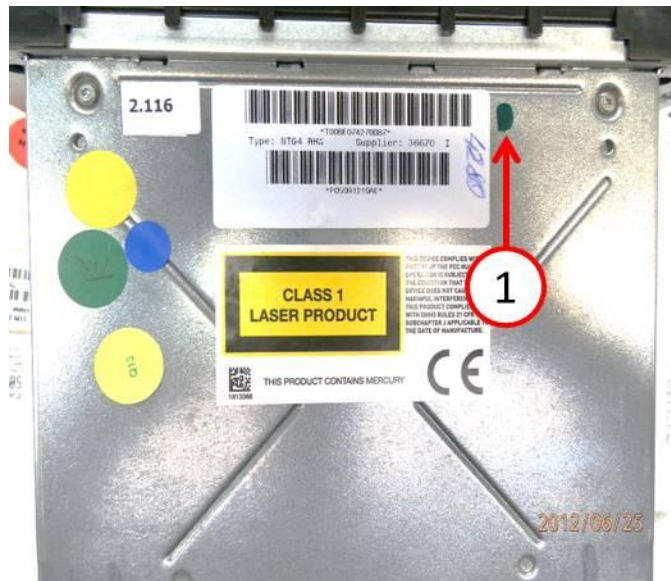
Fig. 1 Updated radios will have a painted green mark.

1 - Location of painted mark.

-
9. Does the radio have a green dot?
 - a. Yes >>> The updated radio has already been installed in this vehicle. Proceed to [Step #10](#).

- b. No >>> The radio needs to be replaced, have the parts person order one from the exchange center. **Put the radio back into the vehicle and give it back to the customer. Once the dealer receive the radio, set up an appointment with the customer to install the updated part.**
