**NUMBER:** 08-026-13

RA3 And RA4 Radio Enhancements

2013 (DS) 1500 Ram Pickup (U.S. only)

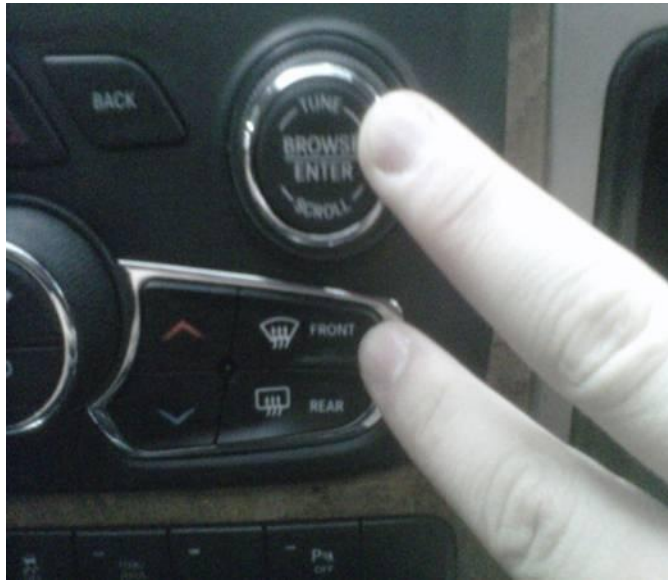
***Fig. 1 Take Vehicle Out Of Ship Mode***

1 - Press and hold these buttons, to put the vehicle in and out of ship mode.

3. Turn the engine on and check if the vehicle is still in ship mode. This will be displayed in the Electronic Vehicle Information Center (EVIC).
4. The vehicle must be in Customer Mode to update the radio. Is the vehicle in Ship Mode?
  - a. Yes >>> Proceed to [Step #5](#)
  - b. No >>> Proceed to [Step #6](#)
5. Press and hold the 'Enter/Browse' button and the 'Front Defrost' (about 5 seconds) until "Ship Mode" is no longer displayed on the instrument cluster, see ([Fig. 1](#)).
