NUMBER: 08-029-13

UConnect Access Feature Cannot Be Successfully Registered

2013 (DS) Ram 1500 Pickup

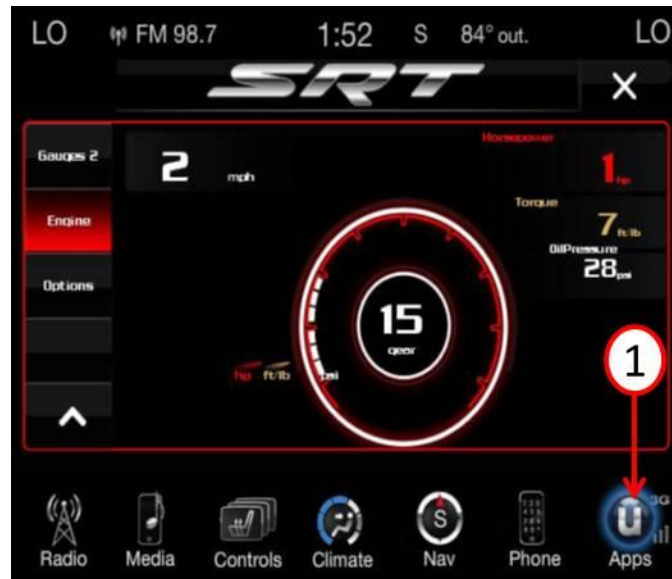
Fig. 1 App Icon with Cell Bar Indicator

1 - Need more than one bar for proper reset.

1. In order to successfully perform the reset, the vehicle must be receiving a 3G cellular signal greater than 1 bar. The Apps Icon located in the lower right corner of the display will indicate the signal strength ([Fig. 1](#))

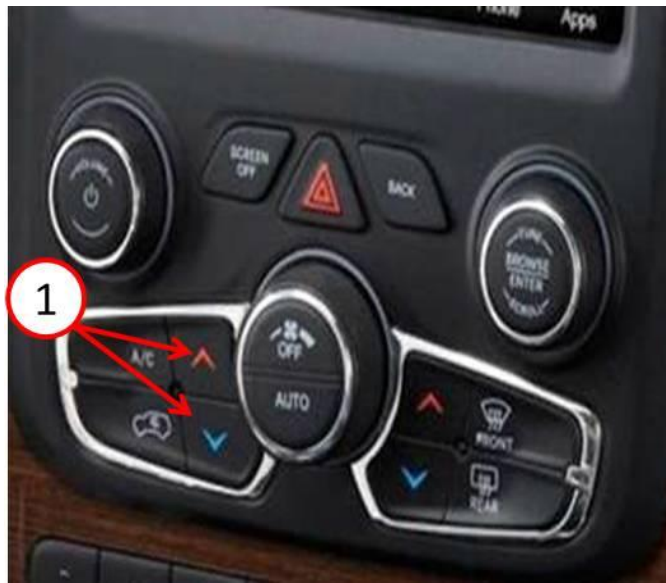
Fig. 2 Entering Reset Mode

1 - Press Up/Down Temp Controls Simultaneously for 5 Seconds

-
2. Enter the Reset Menu by pressing and holding the up and down HVAC temperature control buttons simultaneously for 5 seconds. On dual zone systems press and hold the driver's side control buttons ([Fig. 2](#))

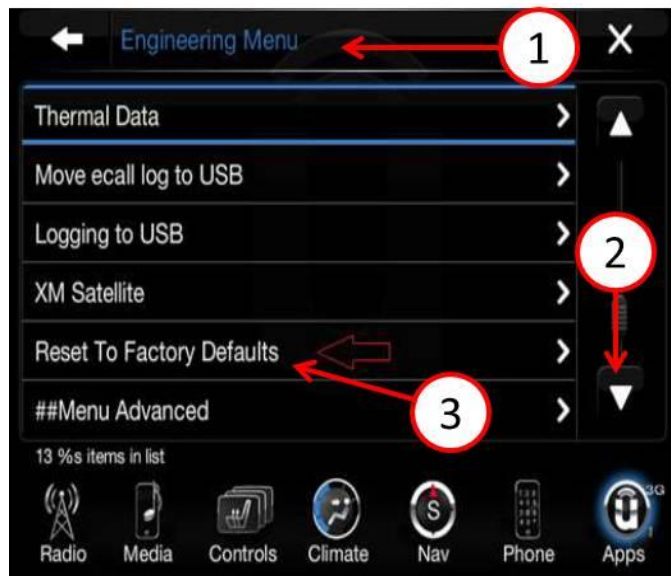
Fig. 3 Engineering Menu

1 - Reset Menu

2 - Scroll Down to Reset Factory Defaults

3 - Factory Reset Selection

3. Scroll down until “Reset to Factory Defaults” is displayed (Fig 3) and press Reset to Factory Defaults(Fig. 3)

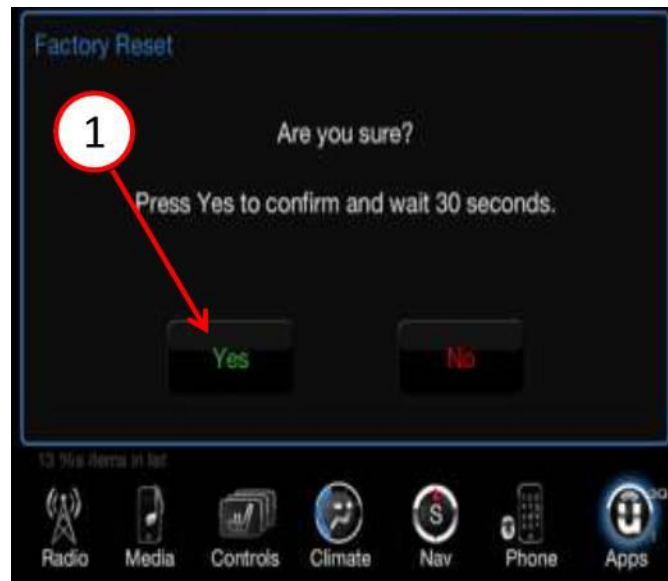
Fig. 4 Factory Reset

1 - Select Yes to Reset Radio

- The following Pop Up will appear, select “Yes” and wait approximately 30 seconds for the radio to reset (Fig. 4).

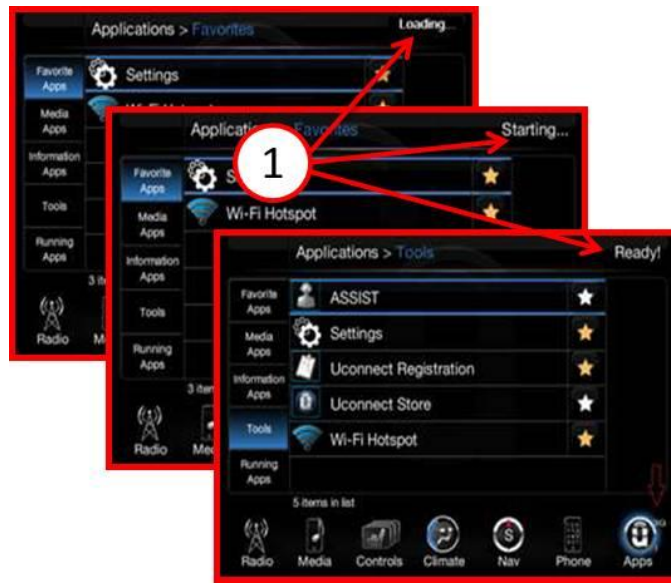
Fig. 5 Applications loading

1 - Loading, Starting and Ready

- Once the radio has powered back up, cycle the ignition off. To ensure that CAN bus has gone to sleep, wait until the USB/SD card slot LED ring goes dark. Then start the vehicle again and complete the 2nd ignition cycles.
- After the 2nd ignition cycle has been completed, turn the vehicle back on.
- When the radio restarts, press the Apps button and the following screen messages will be seen that confirms the unit has successfully been restored and the applications are loading (Fig. 5).
