**NUMBER:** 23-015-13

Ram Box Lid Discoloration (X50 Warranty Extension)

2010 (DS) Ram 1500 Pickup

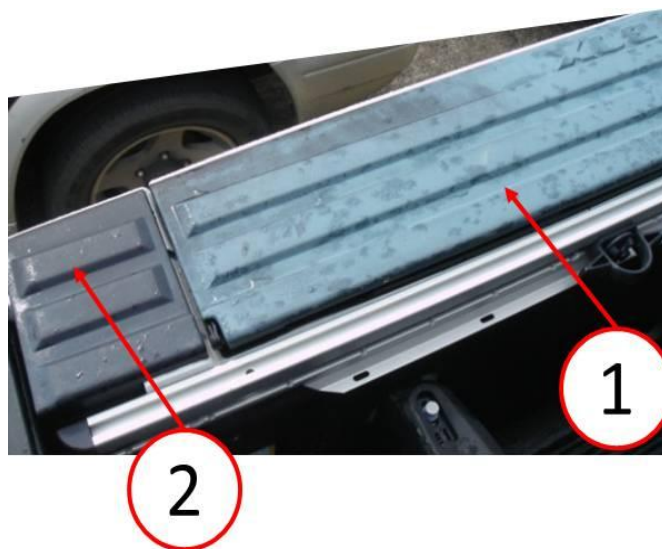
**Fig. 1 Ram Box**

Ram box lid discoloration.

1. Inspect the right and left black texture top surface on the Ram Box Lid. Is the surface fading or does it appear chalky or green ([Fig. 1](#))?
  - a. Yes >>> Replace the suspect Ram Box Lid assembly. Refer to the detailed service information in DealerCONNECT> TechCONNECT> Service Information tab> 23-Body> Box, Pickup> Removal/Installation> RAM BOX STORAGE.
  - b. No >>> Return the vehicle to the customer.
