**NUMBER:** 25-001-13 REV. A

**GROUP:** Emissions Control

MIL Illumination Due to P2000, P2A00 and/or P2A01

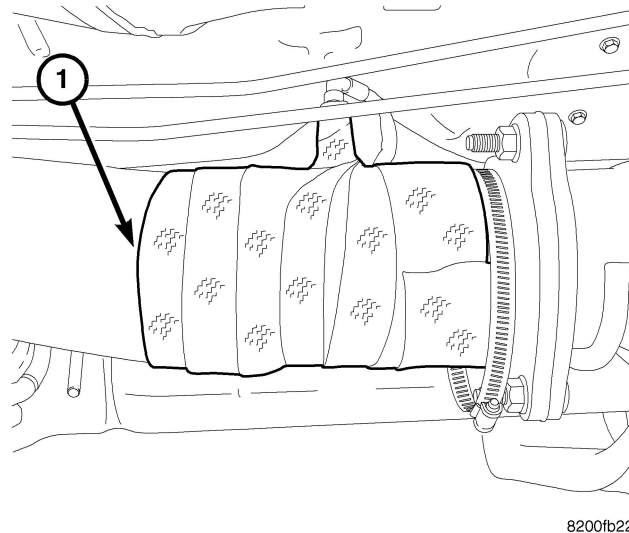
**Fig. 1 O2 SENSOR WRAP**

2. Inspect the front O2 sensor area of the exhaust for the presence of either a wrap or blanket (Fig. 1).

3. Is there a wrap or blanket around the exhaust pipe in the area of the front O2 sensor?
  - a. YES>>>Proceed to the next step.
  - b. NO>>>Proceed to the Repair Procedure.
4. Was the wrap/blanket installed properly and is not damaged or torn/tattered?
  - a. YES>>>This bulletin will not address the symptom/condition. Follow the diagnostic information provided in DealerCONNECT>TechCONNECT>Service Info>Group 28 DTC Based Diagnostics>Module, Engine control (ECM), 6.7L>Standard Procedure>PRE-DIAGNOSTIC TROUBLE SHOOTING PROCEDURE, 6.7L or DealerCONNECT>TechCONNECT>Service Info>Group 29 Non-DTC Diagnostics>Drivability - Diesel, 6.7L>Diagnosis and Testing>PRE-DIAGNOSTIC TROUBLE SHOOTING PROCEDURE, 6.7L.
  - b. NO>>>Proceed to the Repair Procedure.\*\*

1. Raise the vehicle on a hoist.
2. If the vehicle is already equipped with a wrap or blanket but this bulletin is being performed because they are damaged, remove the damaged wrap or blanket from the exhaust pipe.
3. Remove both upstream and downstream Oxygen (O2) sensors.
4. Remove the exhaust pipe. Refer to the procedures identified in DealerCONNECT>TechCONNECT>Service Info>11 - Exhaust System>PIPE, Exhaust>Removal>6.7L DIESEL for additional information.
5. Install heat shield (p/n 68102274AA). Refer to the procedures identified in the Instruction Sheet (p/n K6855747) for additional information.

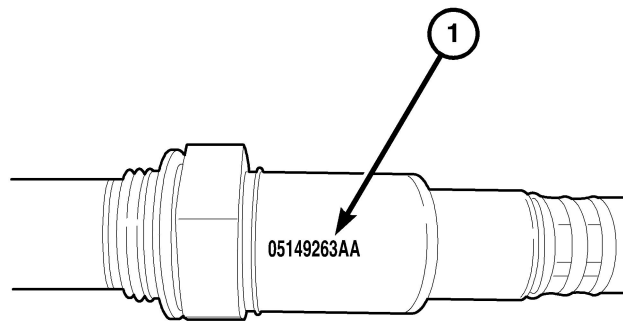
**Fig. 2 O2 SENSOR PART NUMBER LOCATION**

6. Install the exhaust pipe. Refer to the procedures identified in DealerCONNECT>TechCONNECT>Service Info>11 - Exhaust System>PIPE, Exhaust>Installation>6.7L DIESEL for additional information.
7. Inspect both O2 sensors to ensure that the latest sensors are installed in the vehicle. O2 sensors that have p/n 05149263AA (or later) scribed on the sensor, (Fig. 2) are the newer style sensor. If it is difficult to read the part number, the newer style sensor can easily be identified by the soot shield design on the sensor, (Fig. 3).

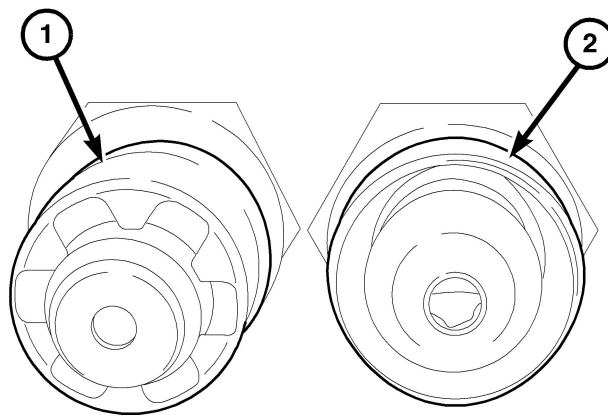
**Fig. 3 O2 SENSOR OLD VERSUS NEW**

1 - EARLY STYLE SOOT SHIELD (OLD SENSOR)

2 - NEW STYLE SOOT SHIELD (NEW SENSOR)

- 8. If the oxygen sensor is not scribed with p/n 05149263AA or newer or if the soot shield appears as the older style soot shield (as seen in (Fig. 3)), replace the oxygen sensors with p/n 05149263AA. If the oxygen sensors are to be reused, clean the O2 sensor using shop air only. **Do not use any solvents or cleaners when cleaning the O2 sensor.** Torque to 41 N•m (30 ft. lbs). Connect wiring to both of the Oxygen (O2) sensors.
