NUMBER: 23-022-13

Wet Carpet At Right And/Or Left Front Floor

2013 (RT) Caravan / Town and Country (Includes International Markets)

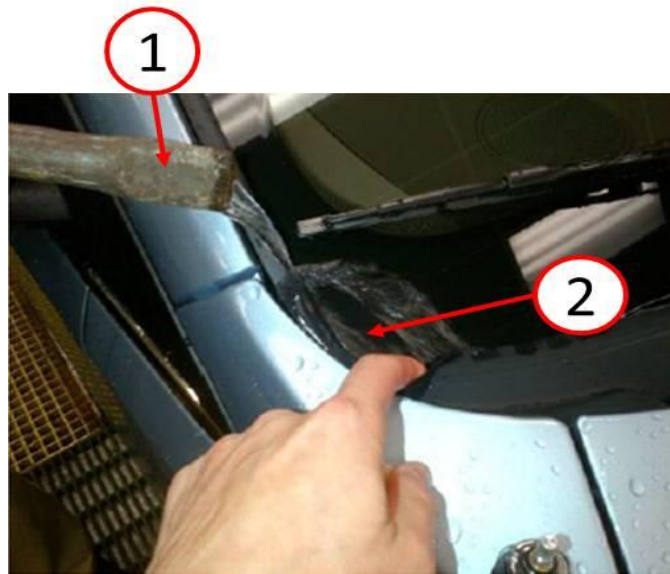
Fig. 1 Water Leak Test

- 1 - Water Hose
 - 2 - Cowl Screen/Windshield/Fender Area
-

1. Inspect the left and right front carpet near the cowl trim panel. Was either side wet?
 - a. Yes>>> Proceed to [Step #3](#).
 - b. No>>> Proceed to [Step #2](#).
2. Apply a steady flow of water at the cowl screen/fender/windshield area ([Fig. 1](#)) for 60 seconds and evaluate the kick panel area ([Fig. 2](#)). Did water begin to enter the vehicle?
 - a. Yes>>> Reinstall the cowl trim panel. Refer to the detailed procedures available in DealerConnect> TechCONNECT under: Service info> 23-Body> Interior> Panel, Cowl Trim> Installation. Proceed to [Step #3](#).
 - b. No>>> Continue further diagnosis, this bulletin does not apply.

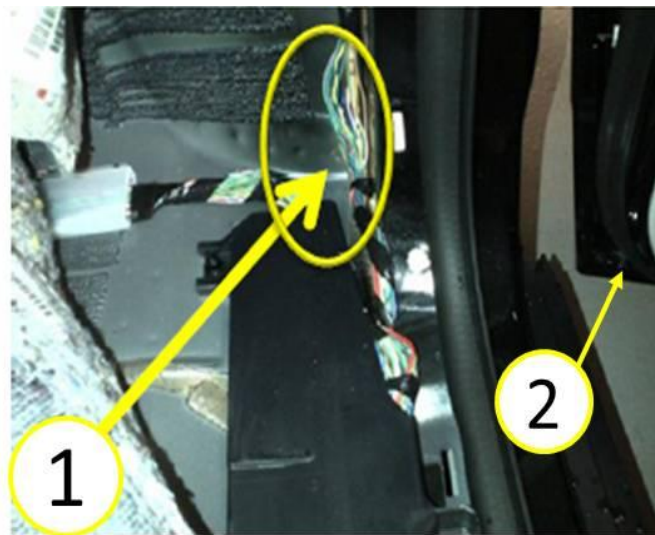
Fig. 2 Front Floor

- 1 - Suspect Leak Area
 - 2 - Right Front Door
-

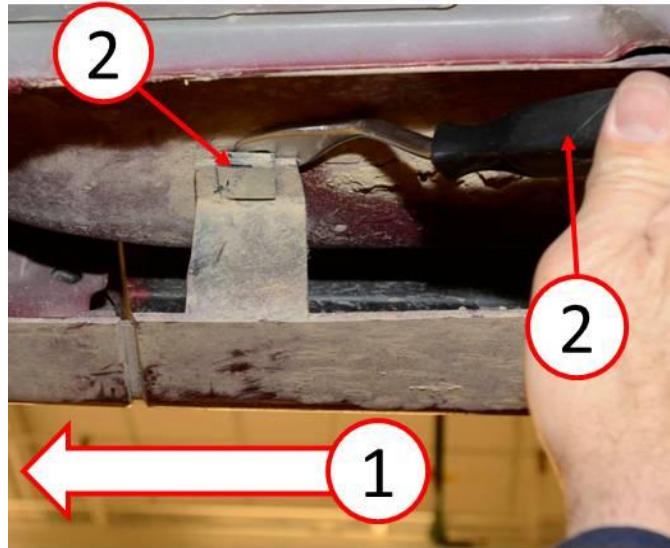
Fig. 3 Right Rear Sill Cladding

- 1 - Front Of The Vehicle
 - 2 - Front Rear Sill Cladding Clip
 - 3 - Clip Removal Tool
-

3. Raise the vehicle on a suitable hoist. Refer to the detailed service procedures available in DealerCONNECT > TechCONNECT under: Service Info > 04- Vehicle Quick Reference > Hoisting > Standard Procedure > Hoisting.
4. Remove the front rear sill cladding clip on the left and right side (Fig. 3). Position the rear sill cladding to access the mounting hole (Fig. 4).

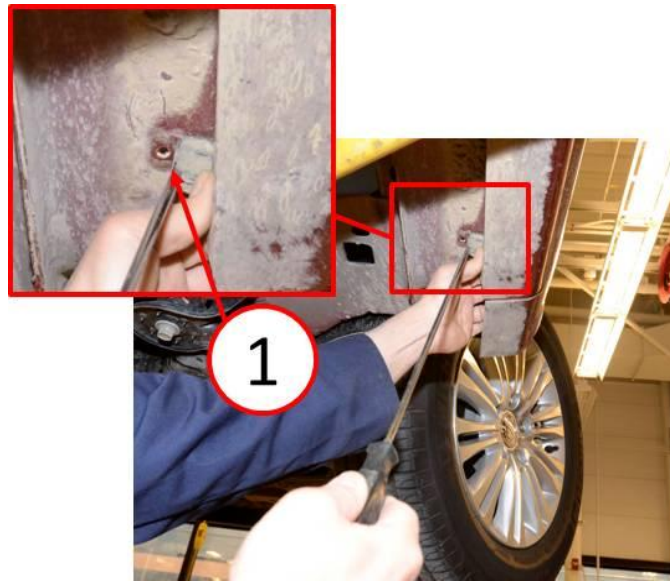
Fig. 4 Mounting Hole

1 - Mounting Hole
