TECHNICAL BULLETIN  
J034NAS1  
13 AUG 2013

**SECTION: 303-12F**

Safety Recall: Engine Charge Air Cooler Hose Detachment

**XF (X250)**

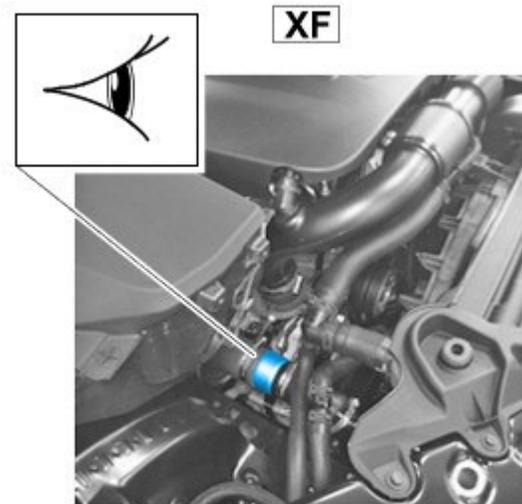
E159753

1. Open hood.
2. Locate the Charge Air Cooler (CAC) hose to the resonator connection.

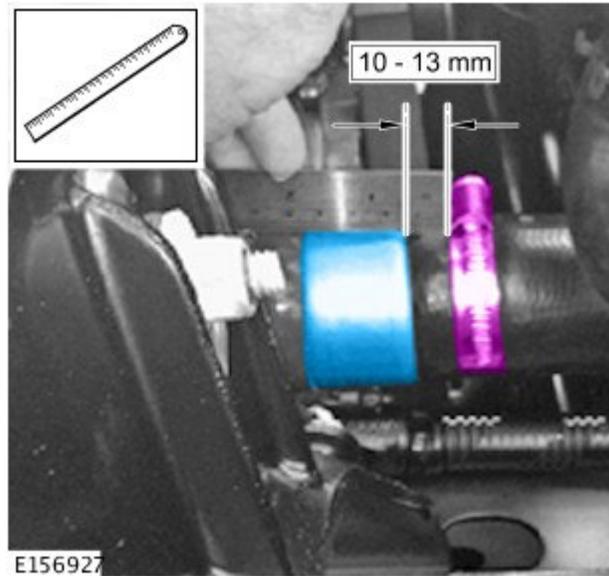
3. Check position of the charge air cooler hose clip.

- If: the clip is less than 10mm from the resonator; a gap exists between the resonator and the end of the hose; or the clip is not positioned squarely on the hose, carry on from step 4.
- If: the clip is between 10mm and 13mm from the edge of the resonator; and the hose is butted against the resonator, carry on from step 5.

4. Reposition hose correctly on the resonator and position the clip 13mm from the edge of the resonator.
5. Tighten the clip to 6Nm, ensuring the clip remains in position and square to the edge of the resonator.
6. Close hood.
