# TECHNICAL BULLETIN

J028NAS2  
10-JAN-13

### Safety Recall: Fuel Starvation

XF (X250)

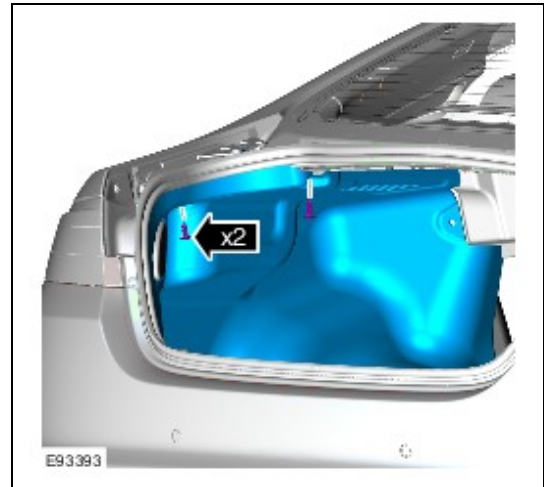
Re-position the RH loadspace trim panel to gain access to the Body Control Module - Back (BCMB) / Auxiliary Junction Box (AJB).

- Remove the two (2) clips.

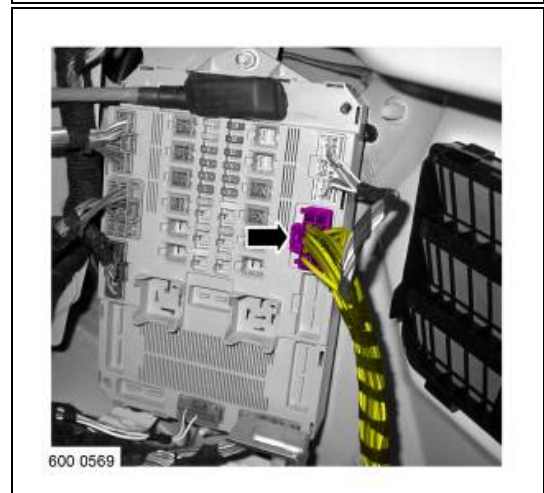
4. Disconnect the connector.

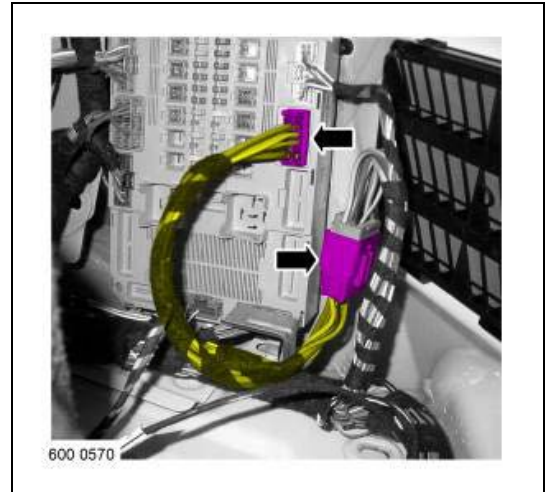
5. Install the new link lead and relay harness.
- Connect the two (2) connectors.

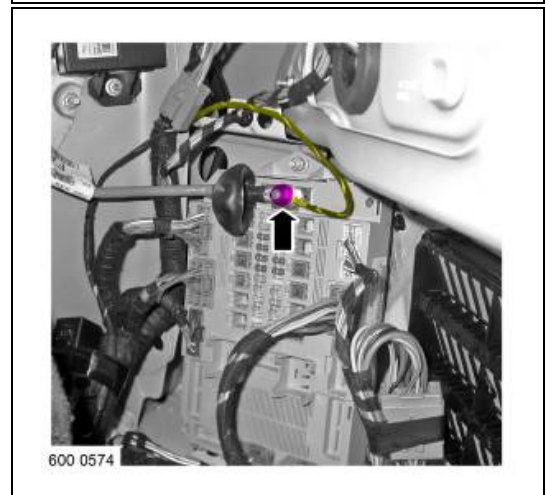
6. Secure the M8 eyelet to the battery cable connection.
- Feed the new harness along the existing harnesses in the position shown.
  - Re-position the battery cable connection cover.
  - Remove the nut.
  - Install the M8 eyelet on the stud.
  - Tighten the nut to 12 Nm.
  - Re-position the battery cable connection cover over the connection.

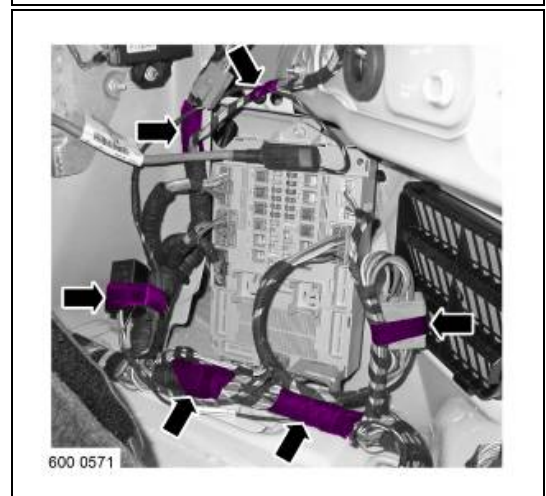
7. Using a suitable tape, secure the new link lead and relay harness to the existing harnesses in the positions shown.

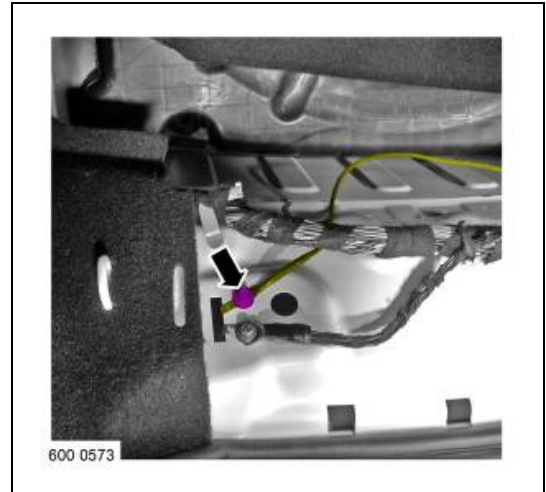
8. Secure the ground cable connection.
- Carefully feed the M6 eyelet along the underside of the existing harness to the LH-side of the luggage compartment.
  - Using a thread-cutting bolt, secure the ground cable in the position shown.
  - Tighten the bolt to 11 Nm.

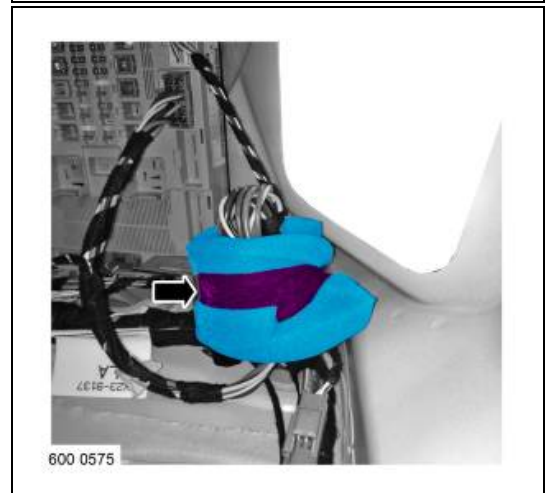
10. Using a suitable tape, secure the foam to the connector.

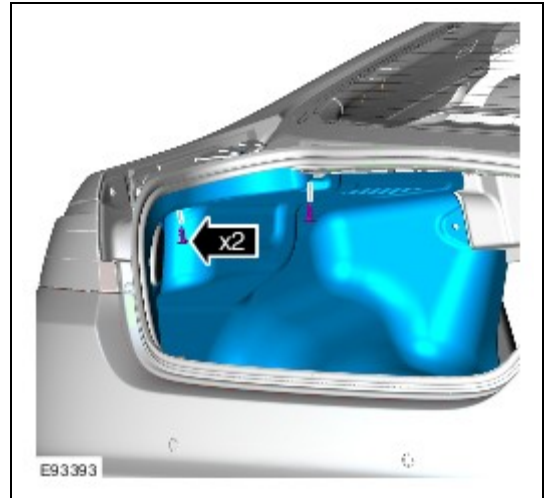
**NOTE: Left-hand shown; right-hand similar.**  
Secure the RH loadspace trim panel.
- Secure the two (2) clips.
