**NUMBER:** 23-012-13

Squeak Coming From Under Front Passenger Seat Storage Bin

2012 - 2013	(JC)	Journey
2012 - 2013	(JF)	Journey (Export)

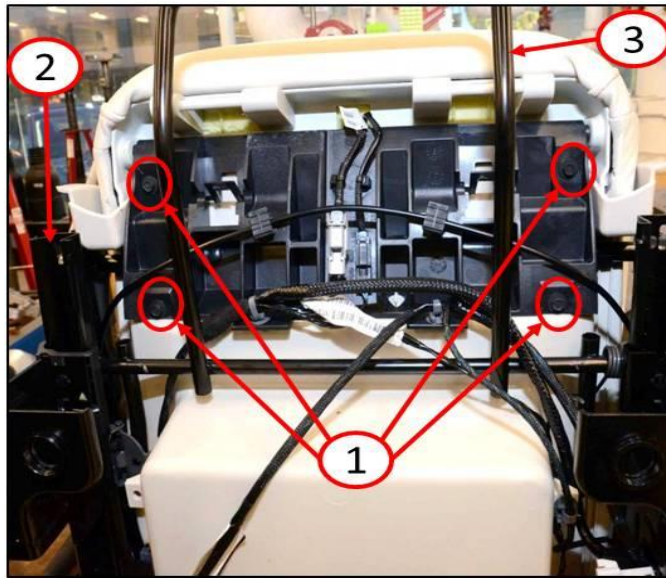
**Fig. 1 Remove Storage Bin**

The seat storage bin is sitting on and rubbing against the seat track cross frame bar at the front of the passenger seat bottom. If the customer describes the symptom, perform the Repair Procedure.

2. Remove the four fasteners (1) and disconnect any retaining clips or connectors in order to remove the seat bottom/storage lid assembly ([Fig. 1](#)).
