Service Bulletin

Subject: **Licence plate support**

Product: **Brutale 1090 – Brutale 1090 R – Brutale 1090 RR - MY 2013 - 14**

Make note to the Service Bulletin N° 119

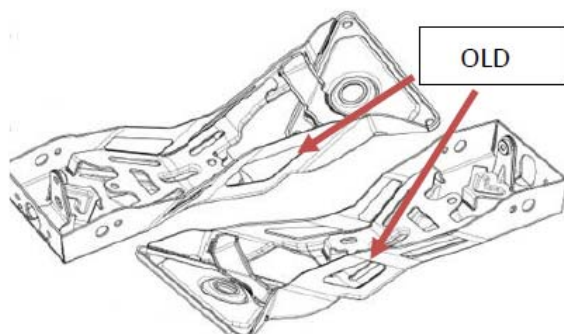
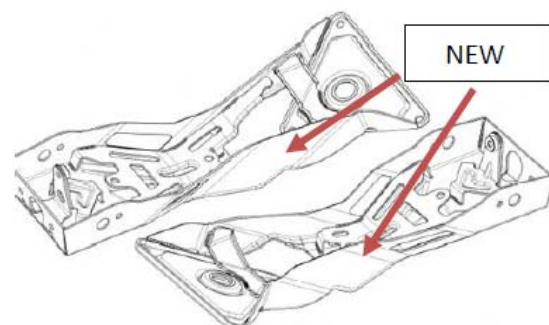
We inform you that it is necessary to install a new licence plate holder P/N 8A00B9192 on the B4 MY 2013-14. These improvements are the result of the continuous quality control of our motorcycles.

- 1) Remove rider's seat - passenger's seat (B4 RR)
- 2) Dismount and move away from its housing the relay and fuse box support bracket.
- 3) Disconnect turn indicators cables and plate light cables
- 4) Remove and displace from it's housing the seat key lock – passenger's seat (B4 RR)
- 5) Remove the 3 fixing screws from the licence plate support
- 6) Remove the licence plate support by gently pulling the cables through the dedicated hole in the inner rear mudguard
- 7) Remove turn indicators and the licence plate light from the licence plate support
- 8) Take the new licence plate support

9) install the new licence plate support by performing the operations described above in reverse order
