# Service Bulletin

Subject: **QUICK SHIFT screw replacement**

Product: **F4 - F4 R - F4 RR - MY 2013**

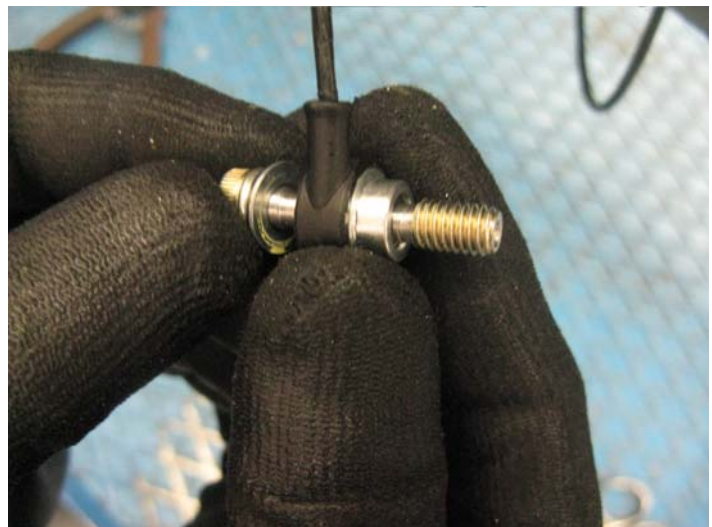
After a continuous product quality monitoring, we found a possible irregularity in the functioning of the EAS system, caused by an interference of the screw with the sensor, it is therefore necessary to replace the EAS sensor and shift lever fixing screw.

- insert the new screw in the EAS sensor, as shown in figure.
