# Technical Service Bulletin

## 19 Coolant warning light or coolant loss - R8 4.2 FSI

19 13 38 2026109/3 May 14, 2013. Supersedes Technical Service Bulletin Group 19 number 13-37 dated May 13, 2013 for reasons listed below.

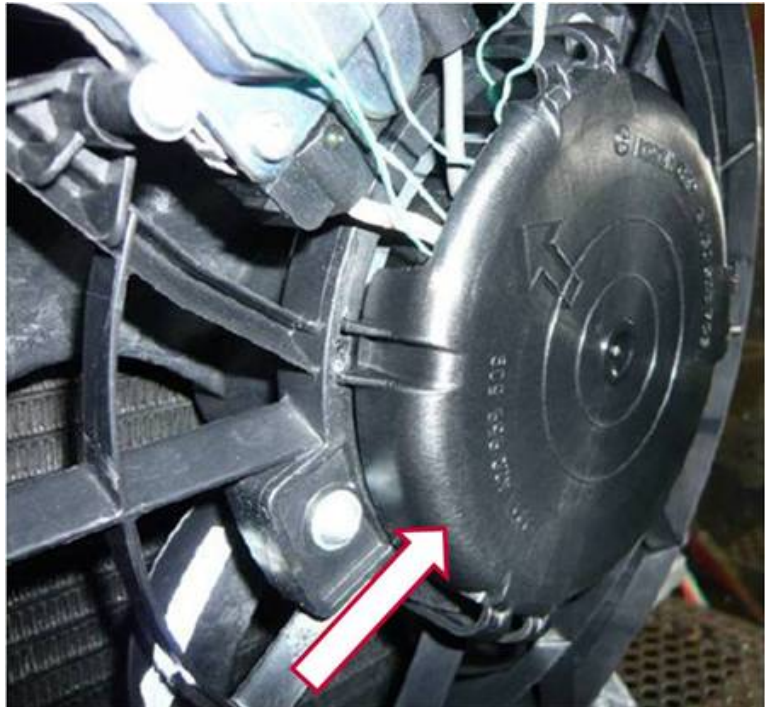
The left and/or right side radiator cooling fans may be inoperative due to corrosion caused by water ingress into the fan motors or into the fan control units. As a result, coolant temperatures may exceed the permissible value, leading to increased system pressure and potential coolant loss from the system. Indication of coolant loss may be noticed coming from the coolant reservoir.

Figure 1. Splash guard aligned with fan control unit.

A splash guard was installed on the cooling fan to protect the fan motor and the fan control unit (Figure 1).

**Tip:** The splash guard must be fitted with the arrow on the splash guard aligned with fan control unit.
