Technical Service Bulletin

19 Coolant leak at connection of water pump and hose leading to the heater core

19 13 40 2033491/2 June 17, 2013. Supersedes Technical Service Bulletin Group 19 number 13-36 dated April 15, 2013 for reasons listed below.

Model(s)	Year	VIN Range	Vehicle-Specific Equipment
A4, A5, A5 cab, Q5, A6	2009-2013	All	2.0 TFSI

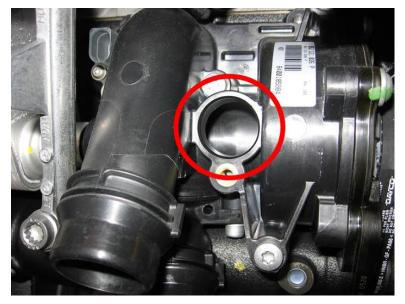
The leak can be traced to the connection of the water pump and the hose leading to the heater core (Figure 1). The seal ring is not the cause of the leak.

Figure 1. Connection of water pump and hose leading to heater core

- 3. After confirming that the leak is a category 3 leak, take a photograph of the leak (use leak talcum spray if necessary) and attach a printout of the photograph to your warranty paperwork.
- 4. Replace the water pump (06H121026CF), seal ring (WHT006407), and the hose to the heater core (06H121065D).

Replacing only the seal ring may not prevent the leak from reoccurring.
