#### 20 Pump nozzle cannot be inserted into fuel tank filler neck, vehicle cannot be refueled

20 13 26 2033836/1 May 15, 2013.

Model(s)	Year	VIN Range	Vehicle-Specific Equipment
A3	2013	All	2.0 TDI Engine

Technical Service Bulletin

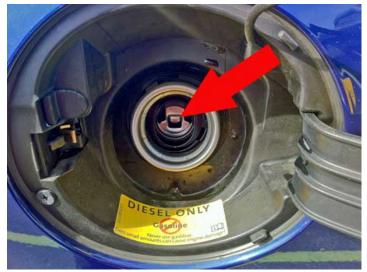
Beginning with MY2013, the filler necks of all A3 TDI vehicles are equipped with a misfueling guard (Figure 1). The guard minimizes the likelihood that fuel other than ultra-low sulfur diesel will be put into the vehicle.

The misfueling guard is designed to remain in a locked position when a nozzle with a diameter typically suited for non-diesel fuels (approximately 13/16", or 20.6mm) is inserted, to prevent further insertion of the nozzle into the filler neck.

A nozzle with a larger diameter typically suited for diesel fuel (approximately 15/16", or 23.8mm) will unlock the misfueling guard when inserted, allowing the nozzle to be further inserted into the filler neck.

Figure 1. Misfueling guard, indicated by red arrow.

Explain to the customer the purpose of the misfuel guard, and how the guard is designed to function.

Also state that some refueling stations may have damaged or worn nozzles with diameters that are out-ofspecification, and that such nozzles may not be able to unlock the misfueling guard. Suggest that in such cases, the customer try turning the nozzle before inserting it into the fuel filler neck, try using a different fuel pump, or see an authorized Audi dealer or authorized repair facility for assistance.

Do not replace the fuel tank, as this is a normal condition.
