Technical Service Bulletin

21 Mil on - P0299 Negative pressure deviation, turbocharger excessive wastegate play

21 13 11 2031245/2 March 6, 2013. Supersedes Technical Service Bulletin Group 21 number 12-10 dated October 25, 2012 for reasons listed below.

Model(s)	Year	VIN Range	Vehicle-Specific Equipment
A4	2009-2010	All	6 speed automatic (0B6)
A5			
A5 Cab

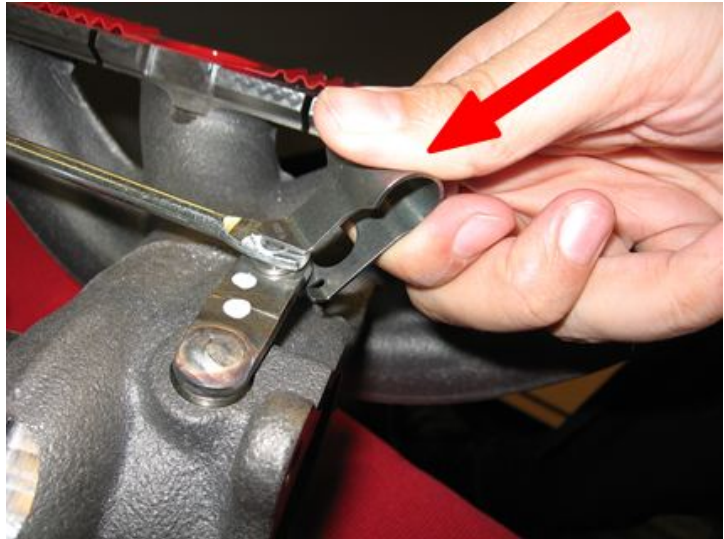
Figure 1. Fit the clip from the side.

1. Remove turbocharger as per ELSA instructions: *Repair Manual >> Engine / Engine Mechanical >> 21 Turbocharger, G-Charger >> Removal and Installation >> Turbocharger.*
2. Install clip **06J145220B** on a replacement turbocharger's link plate and actuating rod joint as illustrated (Figures 1 and 2).

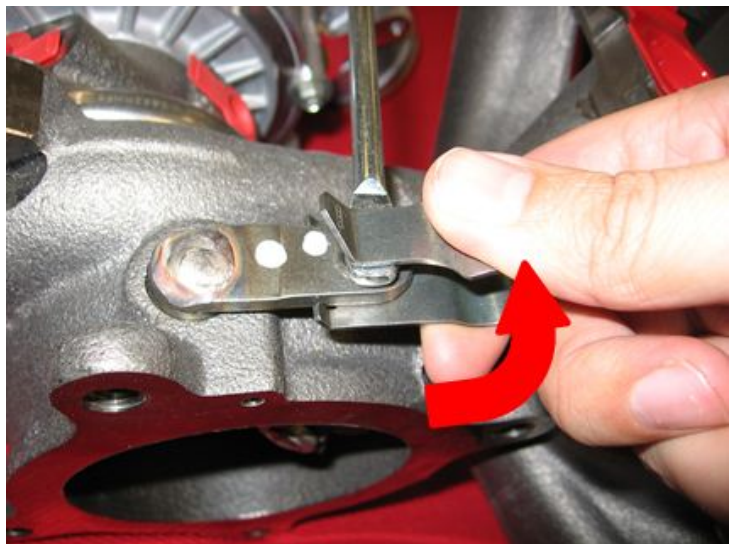
Figure 2. Turn the clip counter clockwise till the lugs slot in.

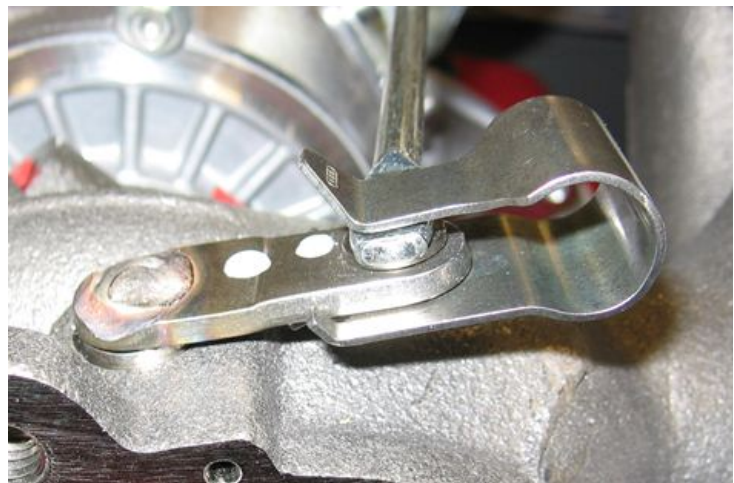
Figure 4. Correctly-fitted clip.

3. After fitting the spring clip, check for correct fit (Figure 4).

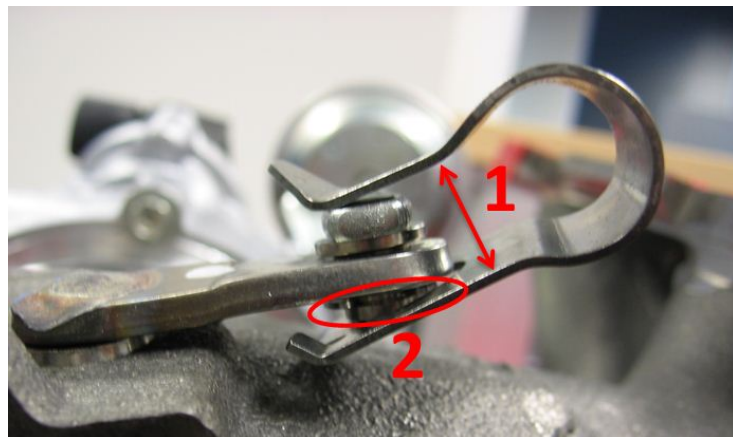
Figure 5. (1) Maximum opening of clip, (2) Position of original circlip

4. After fitting the spring clip, check the position of the original circlip (Figure 5, 2) and correct it if necessary.
