NUMBER: 19-001-13 REV. A

GROUP: Steering

Rattle From Driver Side Of Instrument Panel Or Steering Wheel Over Rough Roads Or When Turning

2014 (WK) Grand Cherokee (Includes SRT8)

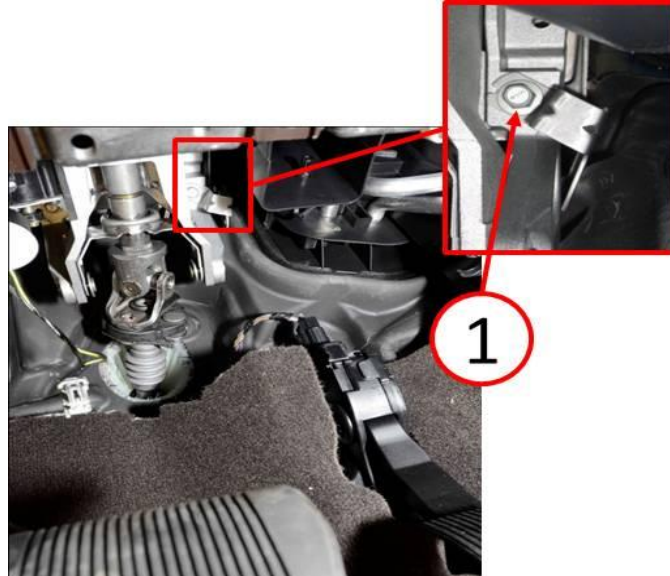
Fig. 1 Steering Column Bracket

Rattle from driver side of instrument panel or steering wheel over rough roads or when turning.

1. **Inspect the vehicle for the steering column lock control module wiring harness bracket (Fig. 1). Is the steering column lock control module wiring harness bracket installed?
 - a. Yes>>> Proceed to [Step #2](#).
 - b. No>>> Return the vehicle to the customer or dealer inventory. **
