Technical Service Bulletin

01 MIL on, R8 Intake Air Hose leaking

01 13 91 2029233/2 May 7, 2013. Supersedes Technical Service Bulletin Group 24 number 12-27 dated April 23, 2012 for reasons listed below.

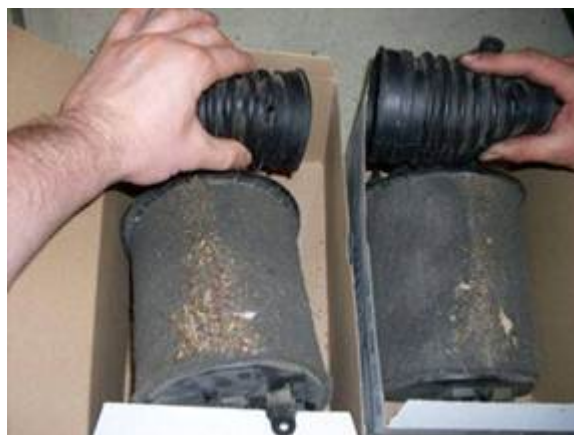
Because the air intake is close to the ground (behind the front wheel), excessive dirt can get into the intake air when the vehicle is driven in unusual conditions. Excessive dirt (Figure 1) can clog the air filter, which may cause illumination of the MIL, misfiring, and fuel trim-related DTCs because:

Figure 1. Example of excessive dirt on air filters.

1. Check for cracks or damage on both of the intake air hoses.
2. If either hose is damaged, replace both hoses and both air cleaner elements.

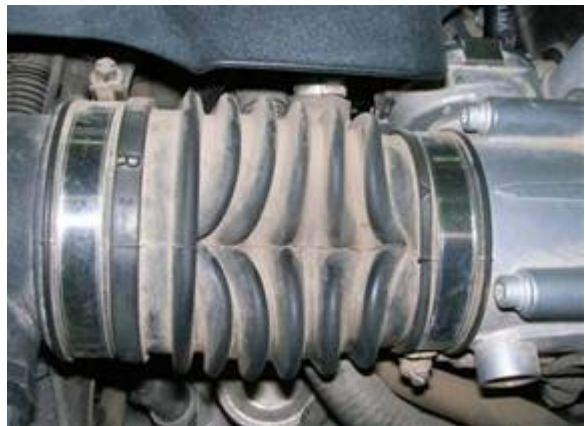
- When the air filter is clogged, not enough intake air is available to the engine, resulting in excessive vacuum in the air duct hose between air filter and throttle valve (Figure 2). The excessive vacuum can damage the air duct hose and cause it to collapse and become deformed. Repeated deformation of the hose causes it to crack.

Figure 2. Vacuum in the air duct hose between air filter and throttle valve.

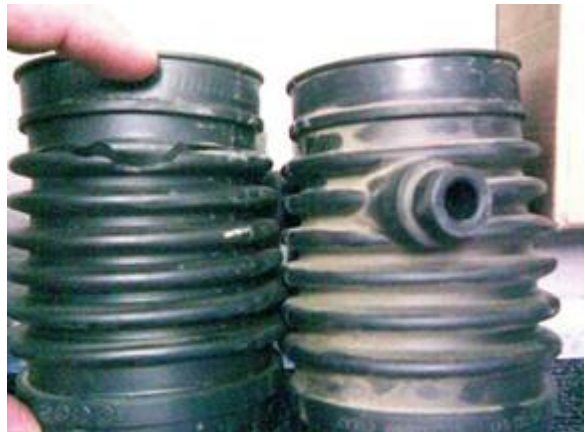
- Bypass air gets in through the crack in the intake hose (Figure 3) which can cause the MIL to become illuminated and can cause fuel trim-related DTCs to be set.

Figure 3. Crack in the intake hose.
