TECHNICAL BULLETIN
LTB00154NAS3
16 DEC 2013

SECTION: 211-02

Squeak Noise From Steering Gear

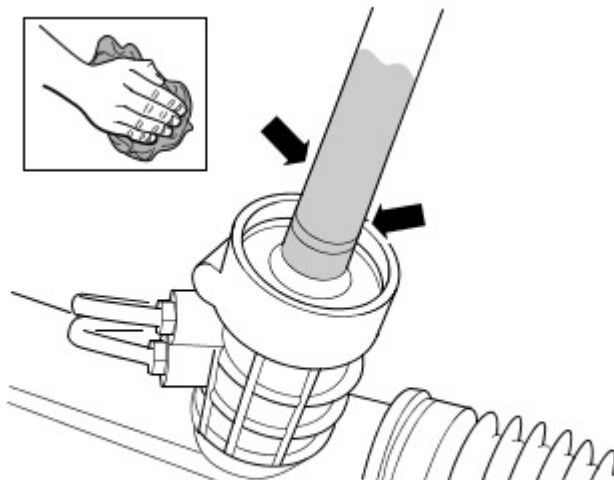
E104317

**NOTE: If any gouge/scratch or damage has occurred to the internal surfaces of the housing, a new steering gear must be installed.**

Clean the pinion shaft and verify that no damage has occurred to the pinion diameter while removing the seal.
