# TECHNICAL BULLETIN

LTB00305NAS2

### **Audible Boom / Vibration at 2,400-2,800 RPM**

LR4 (L319)

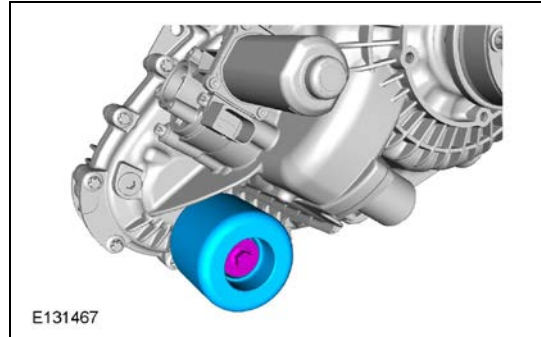
**Situation:** An audible boom may be heard or vibration may be felt through the floor pan or front seat at 2,400 - 2,800 rpm during medium to heavy acceleration (not during cruise or light load situations).

**Cause:** This may be caused by powertrain torsion mode where the transfer box is effectively twisting on the rear of the transmission.

1. Refer to Workshop Manual section 100-02 and raise and support the vehicle.
2. Install the damper (**IAI500100**) and fixing bolt (**IYP500080**) to the unused threaded hole in the transfer case.
  - Torque the bolt to **55Nm (41lb-ft)**.
