TECHNICAL BULLETIN LTB00322NAS3 12 FEB 2013

Upper Windshield Finisher Loose

Range Rover Sport (LS) Model Year: 2006-2013

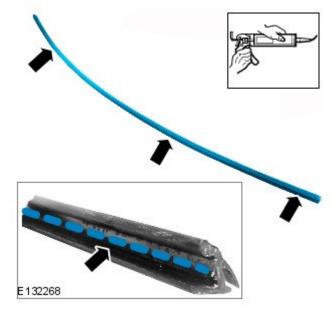
Situation: The upper windshield finisher may be loose or a wind noise may be evident.

Cause: This may be caused by body tolerances in relation to the upper windshield finisher profile.

Apply suitable sealer along the full length of the windshield finisher $\mbox{'}\mbox{U'}$ section or groove.
