TECHNICAL BULLETIN
LTB00493NAS2
19 APR 2013

Tow Hitch Receiver Does not Latch in the Vehicle Housing

LR3 (LA)	Model Year:	2005-2009
	VIN:	5A000360-9A513325
LR4 (LA)	Model Year:	2010-2014
	VIN:	AA510742 - Onwards
Range Rover Sport (LS)	Model Year:	2005-2013
	VIN:	5A900129 - Onwards

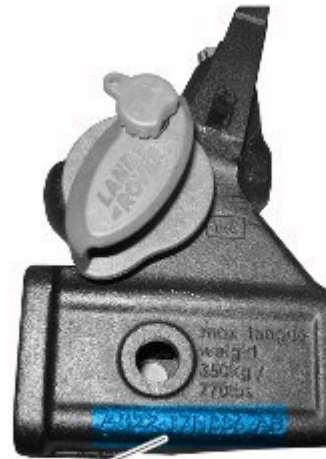
E150665

1. Check the part number on the locking pin and tow hitch receiver. The affected part numbers are listed below:

- Tow hitch receiver part number: **AH22-17N886-AB.**
- Locking pin number (first four digits): **3136U** up to **3257U.**

AH22-17N886-AB

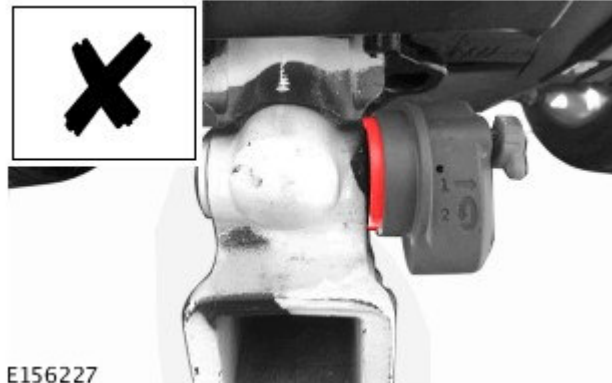
E156227

**NOTE: Note the red signal ring.**

Check to see if the tow hitch receiver latches on the vehicle correctly:

- If the tow hitch receiver is not latched properly, the red signal ring will be visible, the receiver cannot be locked, and the key cannot be removed.

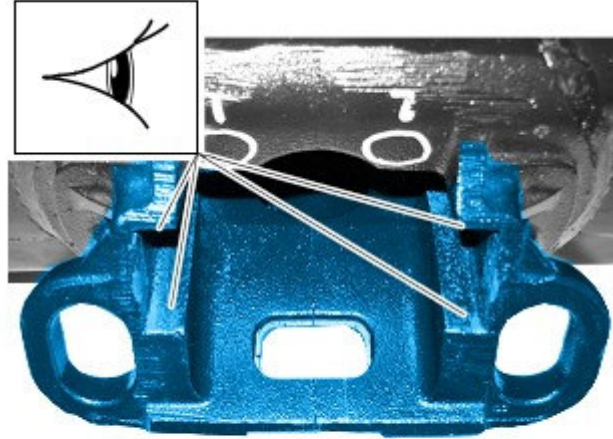
E149649

- Check the housing leeways and the pin surface for dirt, debris, or imperfections.

3. Remove the tow hitch receiver.
