TECHNICAL BULLETIN  
LTB00530NAS1  
08 MAR 2013

**SECTION: 501-10**

'Creak' Noise From Front Seat Base

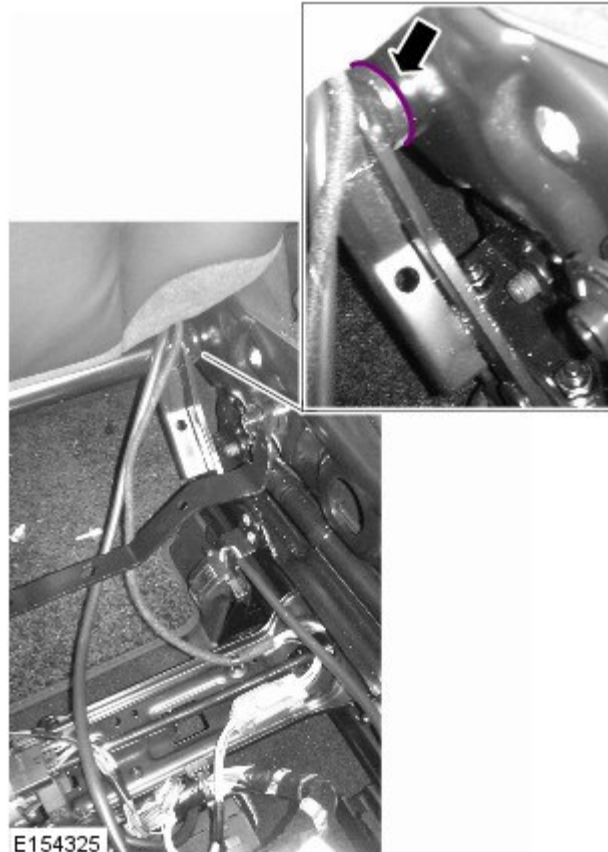
**Situation:** A 'creak' noise may be heard when sitting on the seat cushion.

**Cause:** This may be caused by insufficient lubrication at the seat pivot point.

2. Lubricate the seat pivot point as shown using Nyogel 744L from the Squeaks & Rattles Kit.
